Name of Mine: COWAL GOLD MINE

Titles/Mining Leases: ML 1535

AEMR Commencement Date: 23 DECEMBER 2010

AEMR End Date: 22 DECEMBER 2011

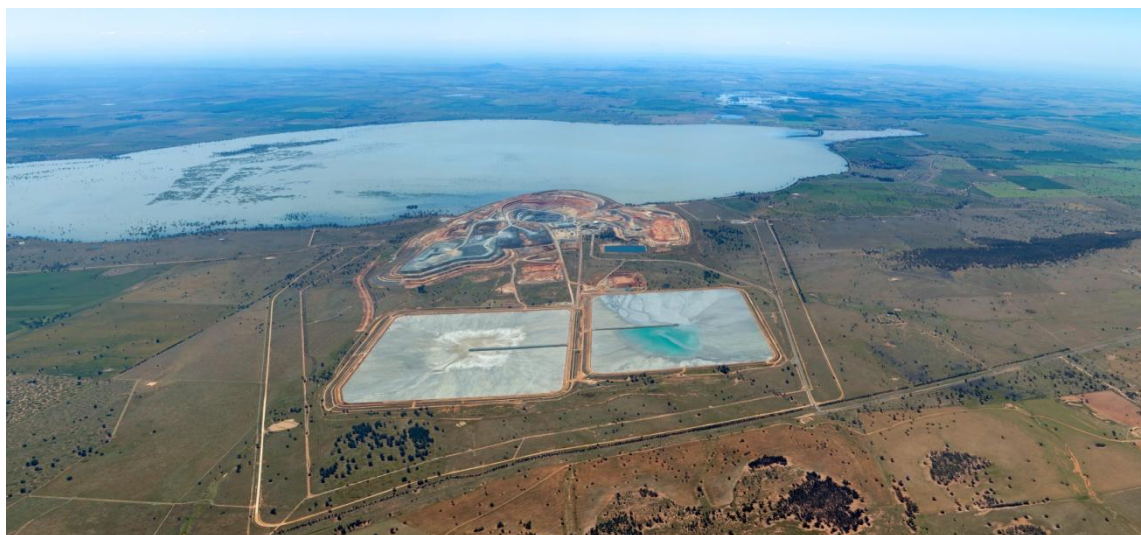
Plate 1 is a low altitude aerial oblique photograph taken west of the TSFs looking east across Lake Cowal. The February 2012 flood event raised the lake level over the top of the majority of the Lignum beds until drainage to the north re-exposed much of the vegetation.

Plate 1
Aerial Photograph from over TSFs towards Lake Cowal (October 2011)

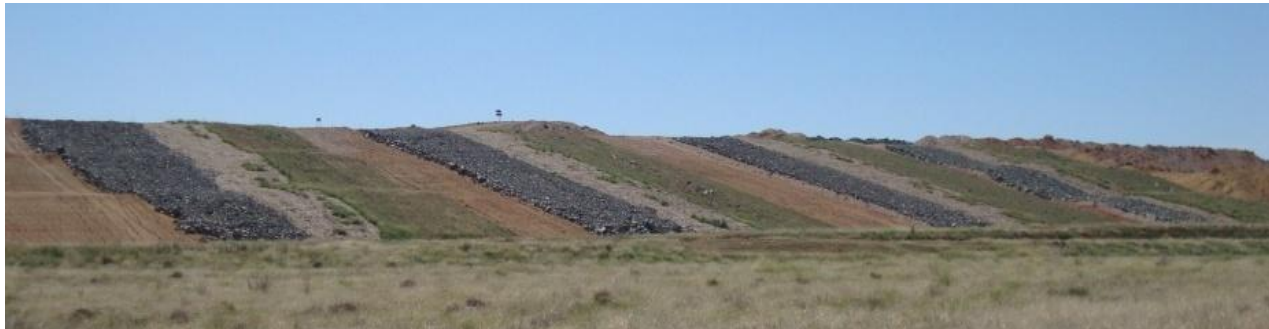
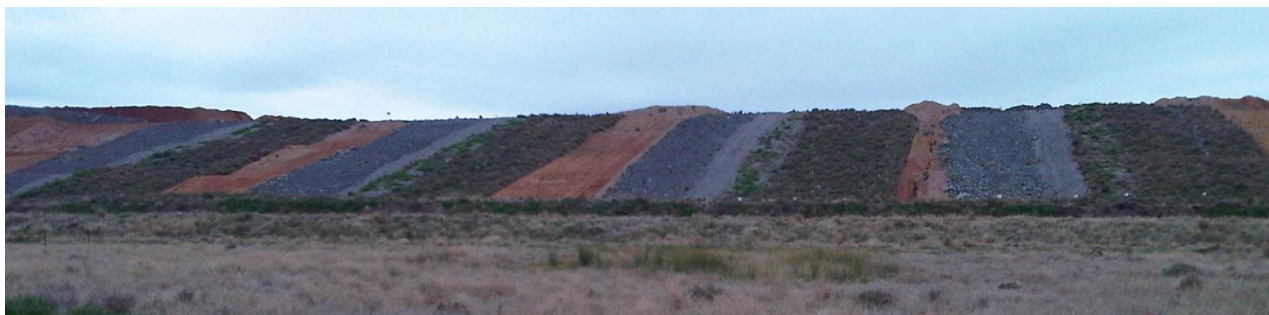
**Plate 2
SWE – Southern Slope Trial Plots**

(Sept 2009)

(July 2011)

No Subsoil							Subsoil																
3 tiered Batter (1:3)				Single continuous slope (1:5)			Single continuous slope (1:5)							3 tiered Batter (1:3)									
R	R+Wc	R,T+Wc	R+T	T	C	R	R+Wc	R,T+Wc	R+T	T	C	R	R+Wc	R,T+Wc	R+T	T	C	R	R+Wc	R,T+Wc	R+T	T	C

The trials were established on the SWE to examine the benefits of rehabilitating slopes with long continuous slopes compared to a three tiered battered slope, with and without different mulching treatments. The layout of the trial is shown above. The trials were constructed in September 2009 as follows using an 8m wide D9 dozer blade as a spacing guide:
