**Name of Mine:** COWAL GOLD MINE

**Titles/Mining Leases:** ML 1535

**Name of Leaseholder:** BARRICK (COWAL) LIMITED

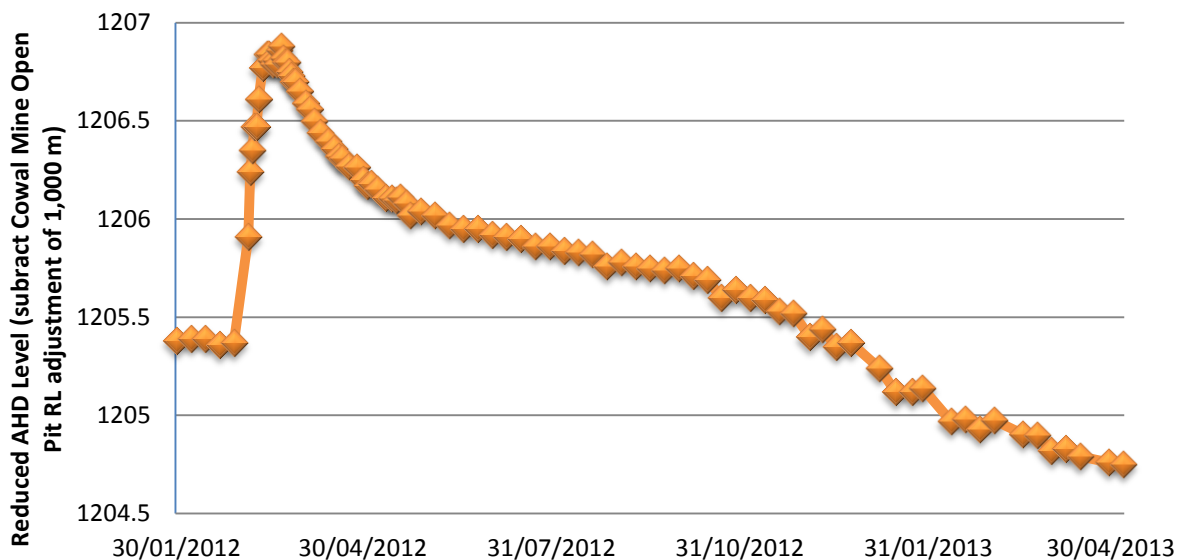
**Plate 2  
Lake Cowal Water Level**

On the 14<sup>th</sup> of March 2012, Lake Cowal was at full capacity for the first time since mining commenced in 2005. This was a result of above average rainfall in February 2012 and heavy rains to the north of Lake Cowal. Plate 2 shows the filling and drying cycle of Lake Cowal.

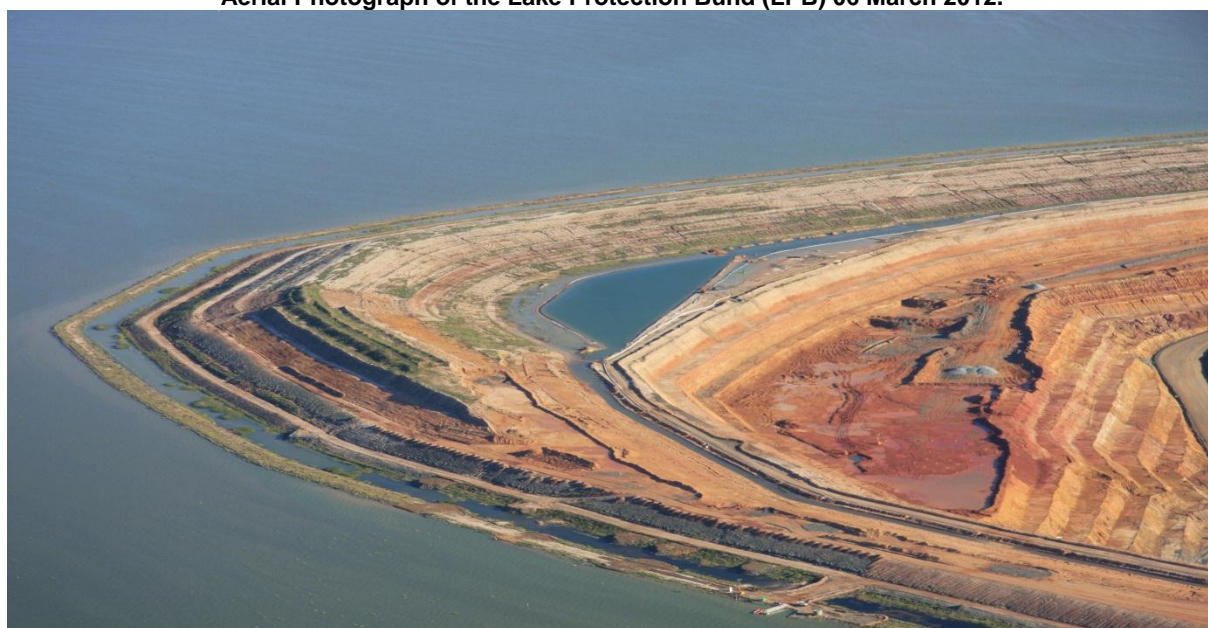
**Plate 3  
Aerial Photograph of the Lake Protection Bund (LPB) 06 March 2012.**

Plate 3 below is a low altitude aerial photograph taken from the north looking south across the Lake Protection Bund. The February 2012 flood event raised the lake level over the top of the majority of the Lignum beds until drainage to the north re-exposed much of the vegetation.

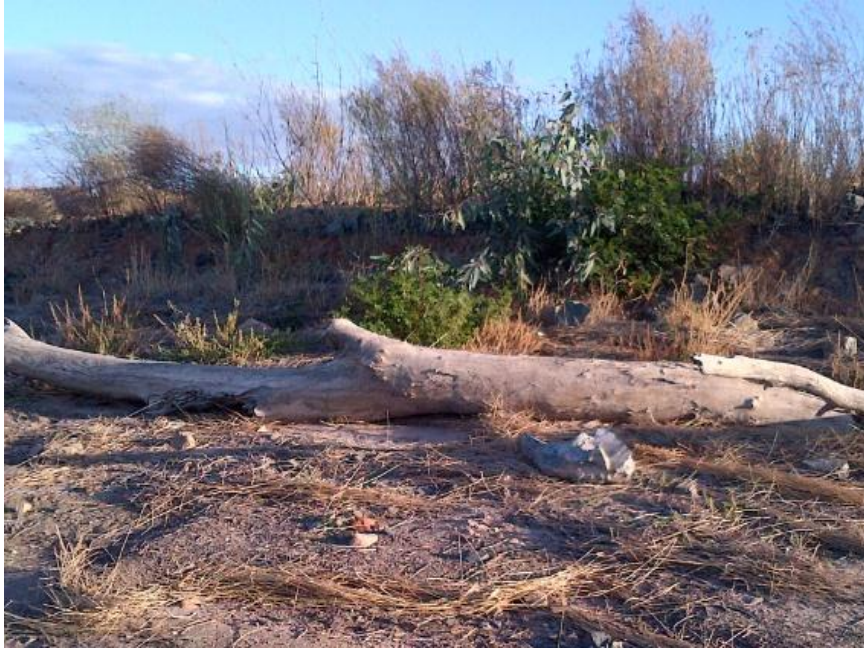
**Plate 7**  
**TIB – Eastern Face Native Re-growth**

Since the inundation of the TIB in March 2012 by the Lake Cowal flood event, there has been significant growth of native plants on the east face of the TIB due to the continued availability of water. The east face of the LPB was adequate to withstand wave action during the flood until the water receded back below the top of the TIB in July 2012.
