<b>Name of Mine:</b>	<b>COWAL GOLD MINE</b>
<b>Titles/Mining Leases:</b>	<b>ML 1535</b>
<b>MOP Commencement Date:</b>	<b>October 2012</b>
<b>MOP Completion Date:</b>	<b>January 2014 - extension to 31 January 2015</b>
<b>AEMR Commencement Date:</b>	<b>23 DECEMBER 2012</b>
<b>AEMR End Date:</b>	<b>22 DECEMBER 2013</b>
<b>Name of Leaseholder:</b>	<b>BARRICK (COWAL) LIMITED</b>
<b>Name of Mine Operator (if different):</b>	<b>AS ABOVE</b>
<b>Reporting Officer:</b>	<b>GARRY PEARSON</b>
<b>Title:</b>	<b>ENVIRONMENTAL MANAGER</b>
<b>Signature:</b>	.....
<b>Date:</b>	<b>12 August 2014</b>

**Plate 1  
Lake Cowal in receding phase (23 January 2014)**

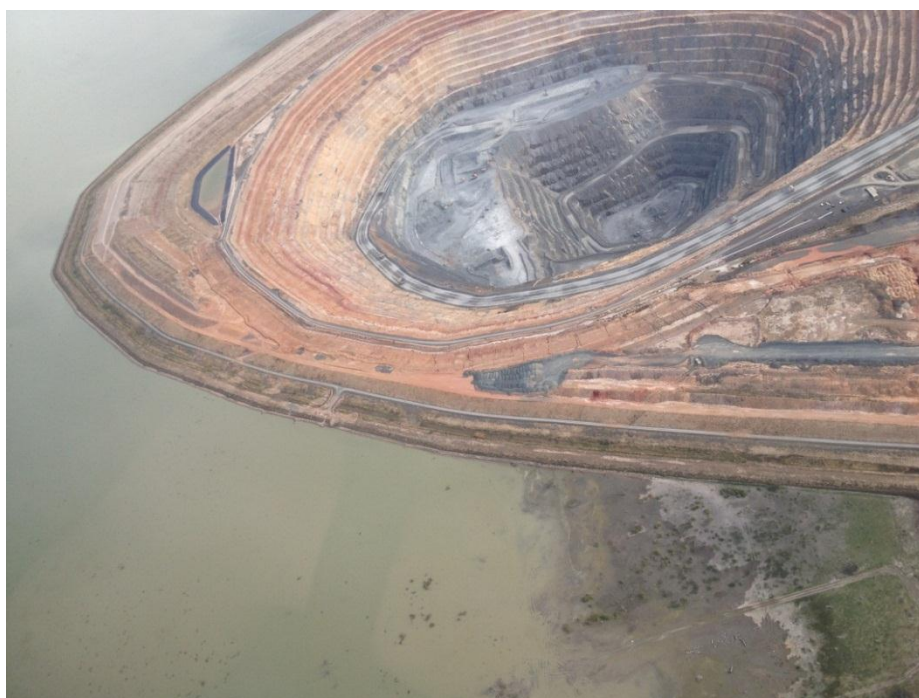
**Plate 3  
Aerial Photograph of the Lake Protection Bund (LPB) January 2014.**

Plate 3 below is an aerial photograph taken from the North looking South towards the open-pit. The photograph was taken 23 January 2014 and depicts vegetation cover just to the North of the open-pit that grew quickly after lake recession. Lake water at this stage abutted the perimeter Lake Protection Bund.

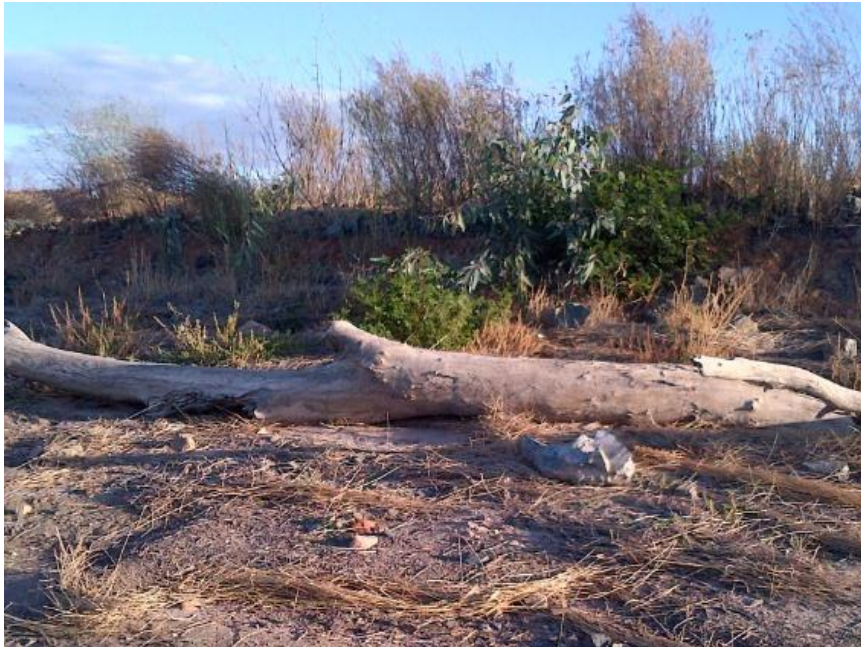
**Plate 6**  
**TIB – Eastern Face Native Re-growth**

Since the inundation of the TIB in March 2012 by the Lake Cowal flood event, there has been significant growth of native plants on the east face of the TIB due to the continued availability of water. The east face of the LPB was adequate to withstand wave action during the flood until the water receded back below the top of the TIB in July 2012.

The temporary isolation bund was constructed to RL 206.5m, has a crest length of 3,170m and reaches a height of 2m in the centre of the arc. Approximately 180,000m<sup>3</sup> of fill was required for construction. Settlement analysis undertaken by SNC Lavalin (SNC Lavalin, 2004) indicated the subsurface formation is typically well consolidated and any settlement is likely to cease soon after completion of the construction period. Prior to commencement of construction and, in accordance with the EIS, a silt fence was erected to provide the lake protection from any sediment laden runoff. Prior to the placement of fill, the upper approximate 300mm of topsoil was stripped from the footprint area of the bund and stored for later rehabilitation of the bund. The bund was constructed in short sections with placement and compaction of the fill section in 0.3m lifts. Following construction of the bund to its final height the structure was shaped and the side slopes were flattened to slopes of 4(H):1(V) on the mine side and 5(H):1(V) on the lake side (Barrick, 2007). Further details on rehabilitation of the structure are provided in Paragraph 4 of the 2012 – 2014 MOP (Barrick, 2012).
