# **COWAL GOLD OPERATIONS**

## **2016 ANNUAL REVIEW**

<b>Name of Operation</b>	<i>Cowal Gold Operations</i>
<b>Name of Operator</b>	<i>Evolution Mining (Cowal) Pty Limited</i>
<b>Development Consent</b>	<i>DA 14/98</i>
<b>Name of Holder of Development Consent</b>	<i>Evolution Mining (Cowal) Pty Limited</i>
<b>Mining Lease #</b>	<i>ML 1535</i>
<b>Name of Holder of Mining Lease</b>	<i>Evolution Mining (Cowal) Pty Limited</i>
<b>Environmental Protection Licence #</b>	<i>EPL11912</i>
<b>Name of Holder of EPL</b>	<i>Evolution Mining (Cowal) Pty Limited</i>
<b>Water Licence #</b>	<i>WAL 36569, WAL 31864, WAL 36615, WAL 36617, WAL 13749, WAL 14981, WAL 13748</i>
<b>Name of Holder of Water Licence</b>	<i>Evolution Mining (Cowal) Pty Limited</i>
<b>MOP Start Date</b>	<i>1 September 2016</i>
<b>MOP End Date</b>	<i>31 August 2018</i>
<b>Annual Review Start Date</b>	<i>1 January 2016</i>
<b>Annual Review End Date</b>	<i>31 December 2016</i>

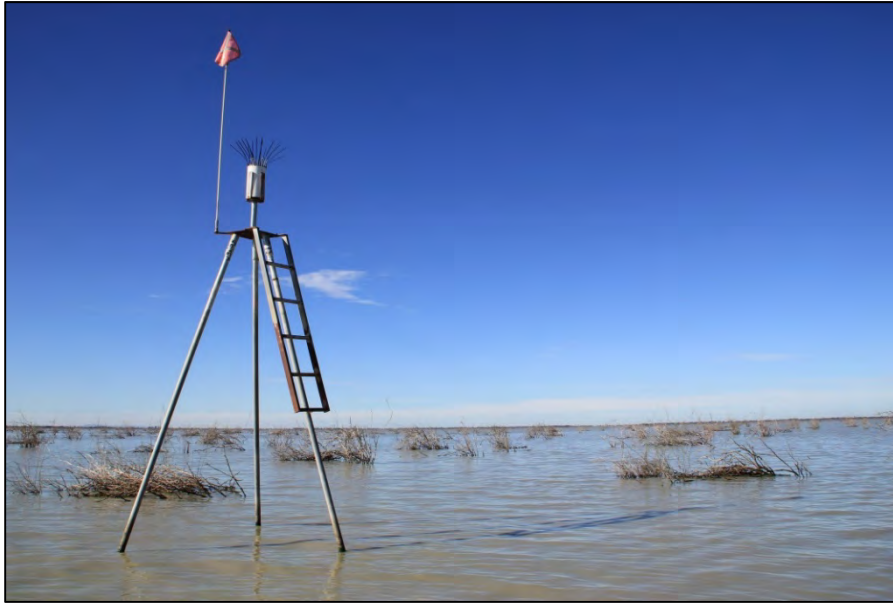
**Plate 1: Elevated Depositional Dust Gauge within Lake Cowal**

Due to high winter and spring rainfall, significant regional flooding and the inundation of Lake Cowal, many of the depositional dust gauges within and surrounding Lake Cowal were inaccessible or inundated during the reporting period. Many of the inundated dust gauges were already mounted on 5 m tripods to raise them above the previous high water mark reached in 2012 (Plate 1). The inundation and inaccessibility of a number of depositional dust gauges significantly influenced the results of the depositional dust monitoring programme during the reporting period. A summary of the dust deposition results for the reporting period is provided in Table 10.

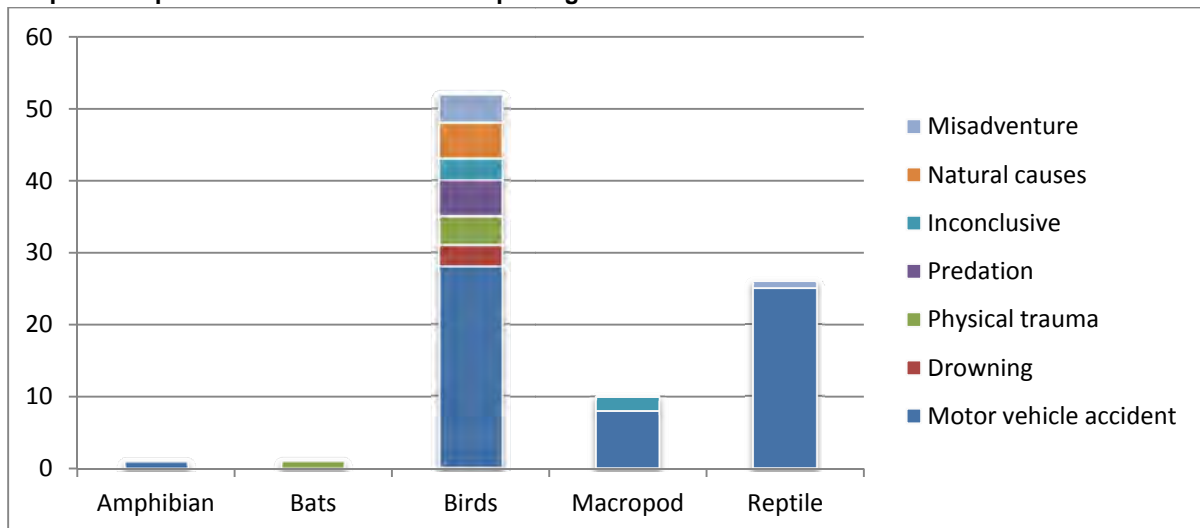
**Graph 1: Graph of Fauna Deaths for the Reporting Period**

There were a total of 90 fauna incidents on ML 1535 during the reporting period. All injured or deceased fauna were taken to the local vet for examination. Over two thirds of the fauna incidents were reported as motor vehicle accidents while none were reported as cyanide related (Graph 1).

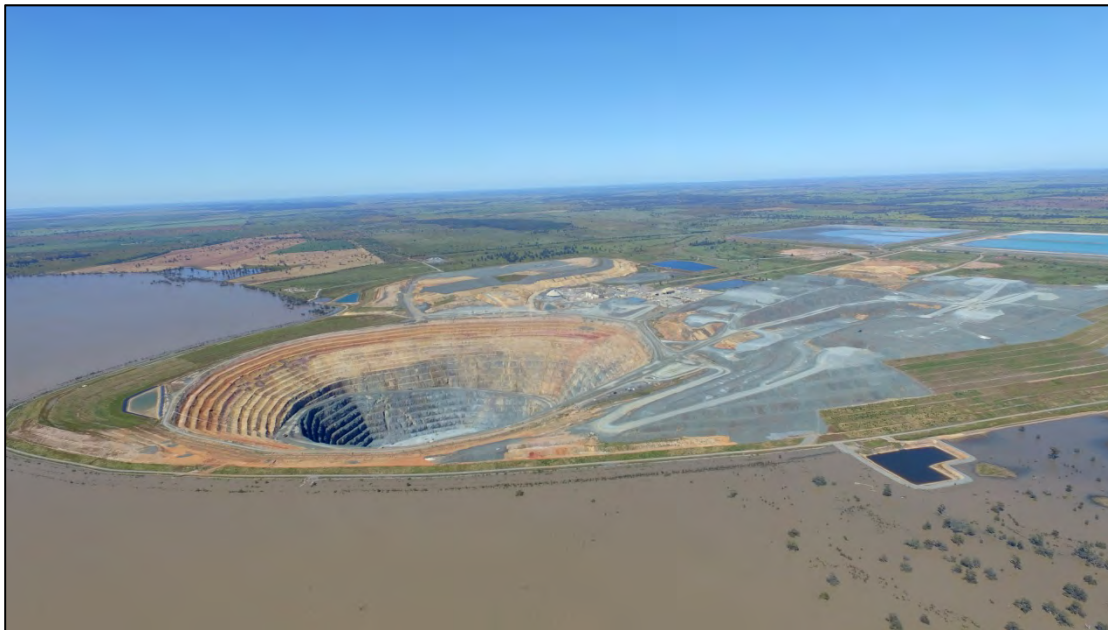
#### **Plate 2: Aerial Photograph of the Lake Protection Bund**

During the reporting period, Lake Cowal was completely inundated following high rainfall events throughout the winter months and subsequent flooding of the Lachlan River and Bland Creek (Plate 2).

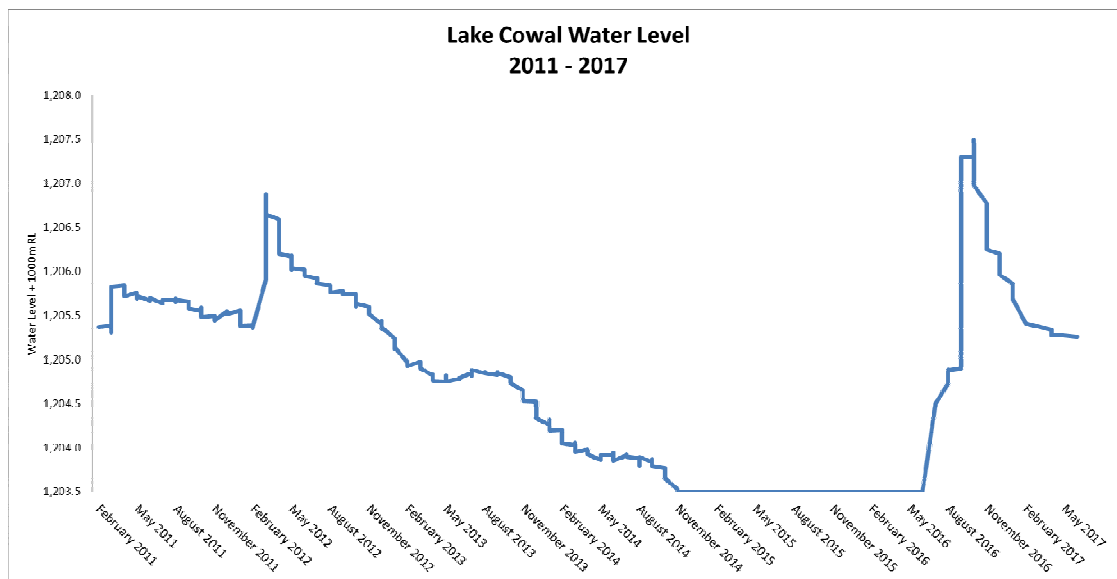
**Graph 2: Lake Cowal Water Level 2011 - 2017**

Lake Cowal peaked at a height of 207.49 m RL on 10 October 2016, before steadily receding back to 205.9 m RL by the end of 2016 (Graph 2).

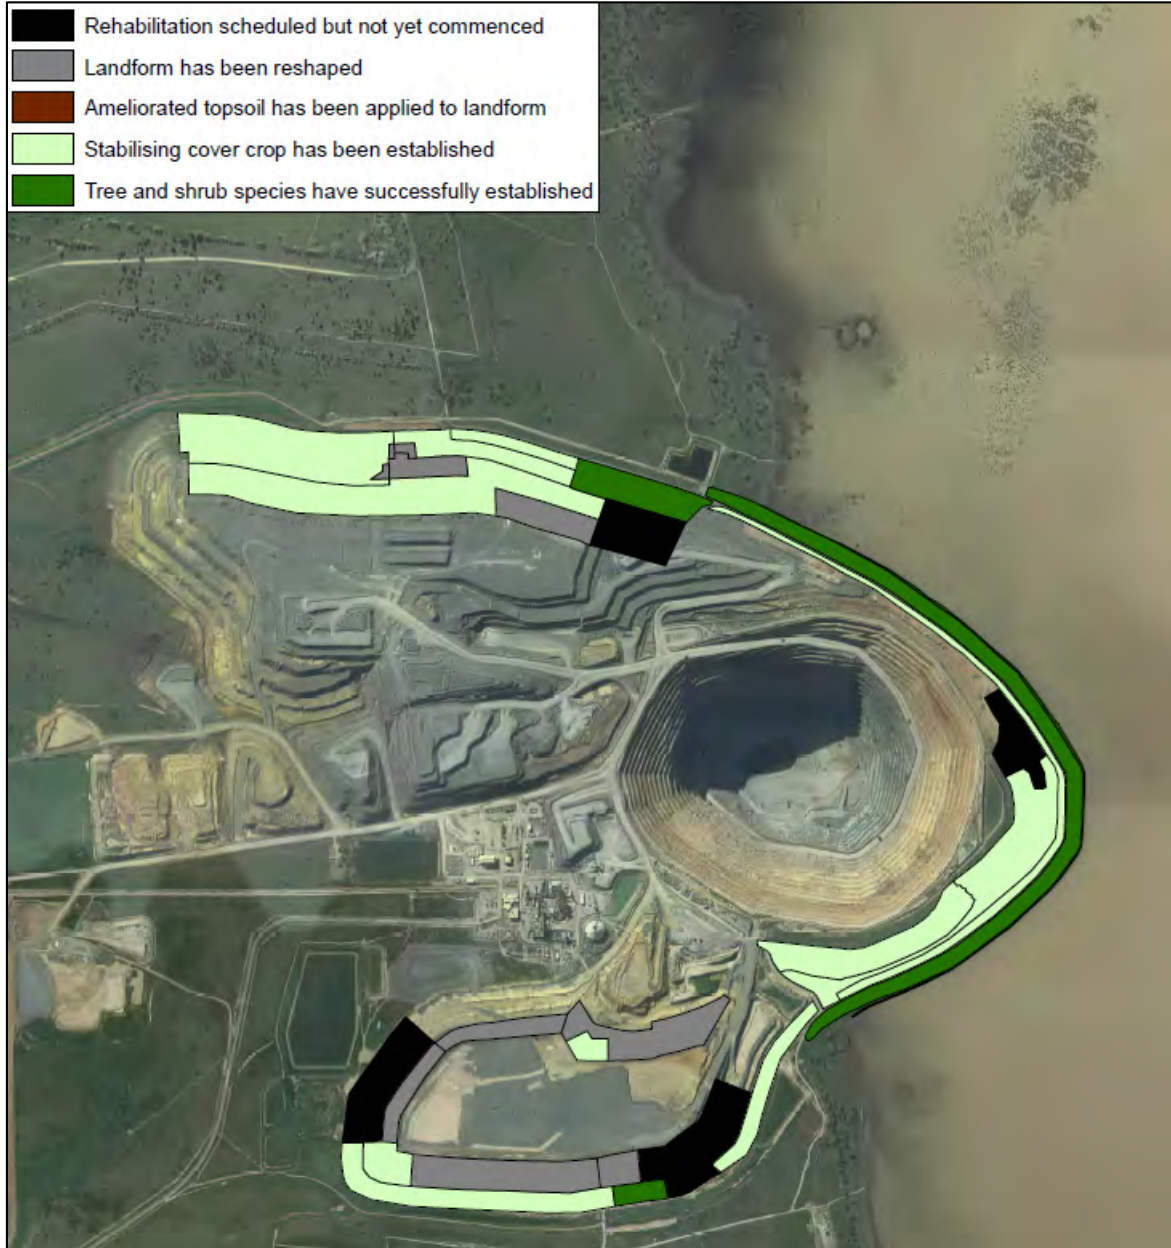
**Plate 3: Conceptual View of Rehabilitated Areas During the Reporting Period**

Table 26 provides details of the nature of disturbance, area and rehabilitation status for areas that have been disturbed up to and including the reporting period. Plate 3 shows the areas under rehabilitation as at December 2016.

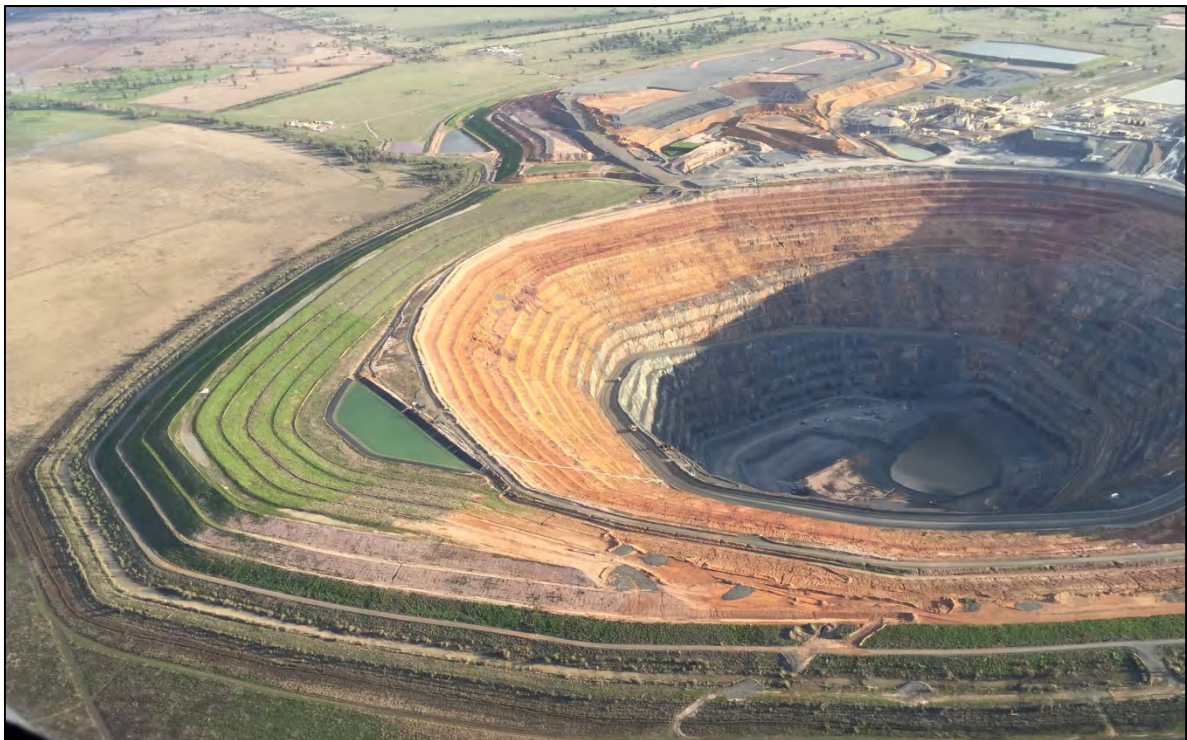
### **Plate 1: North Side of Perimeter Waste Rock Emplacement**

The PWRE has been constructed to approximately 223 m RL and surrounds the pit to the north, east and south (Figure 3). The emplacement occupies an area of approximately 60 ha and forms part of the series of embankments (i.e. Temporary Isolation Bund and Lake Protection Bund) between the open pit and Lake Cowal. The emplacement elevation has been designed to reduce potential noise and light impacts of mining and processing on the surrounding environment and sensitive receptors.

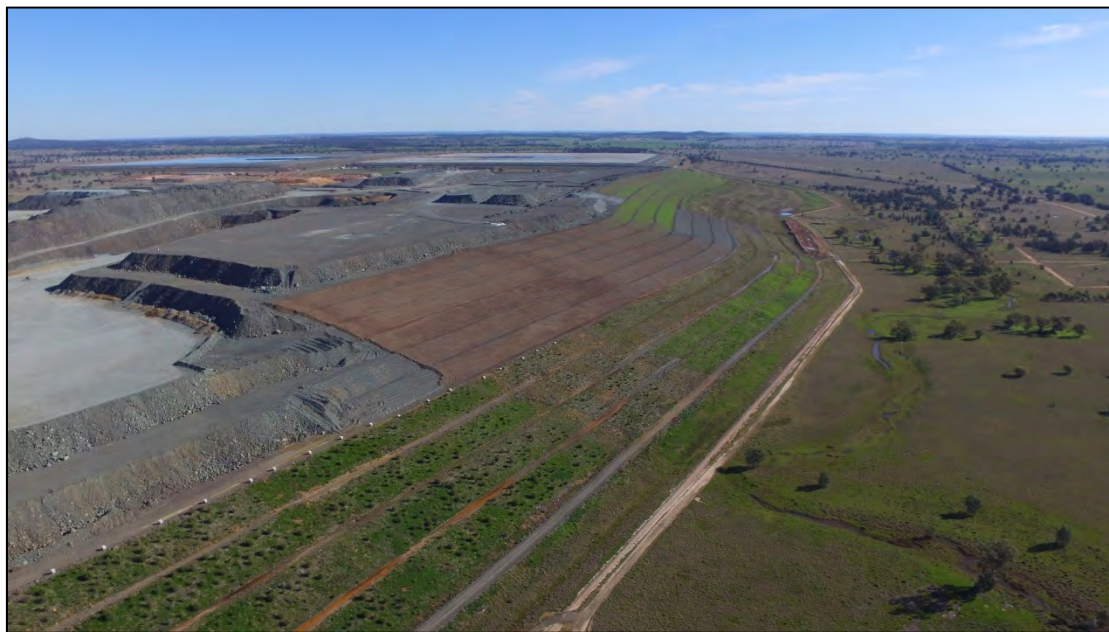
**Plate 2: North Side of Northern Waste Rock Emplacement (June 2016)**

The NWRE is approved to be constructed to approximately 308 m AHD and will occupy an area of approximately 269 ha northwest of the pit (Plate 5).

Tubestock planted within the D1 trial area to replace those lost after the initial planting in 2014, were watered and monitored during the reporting period.

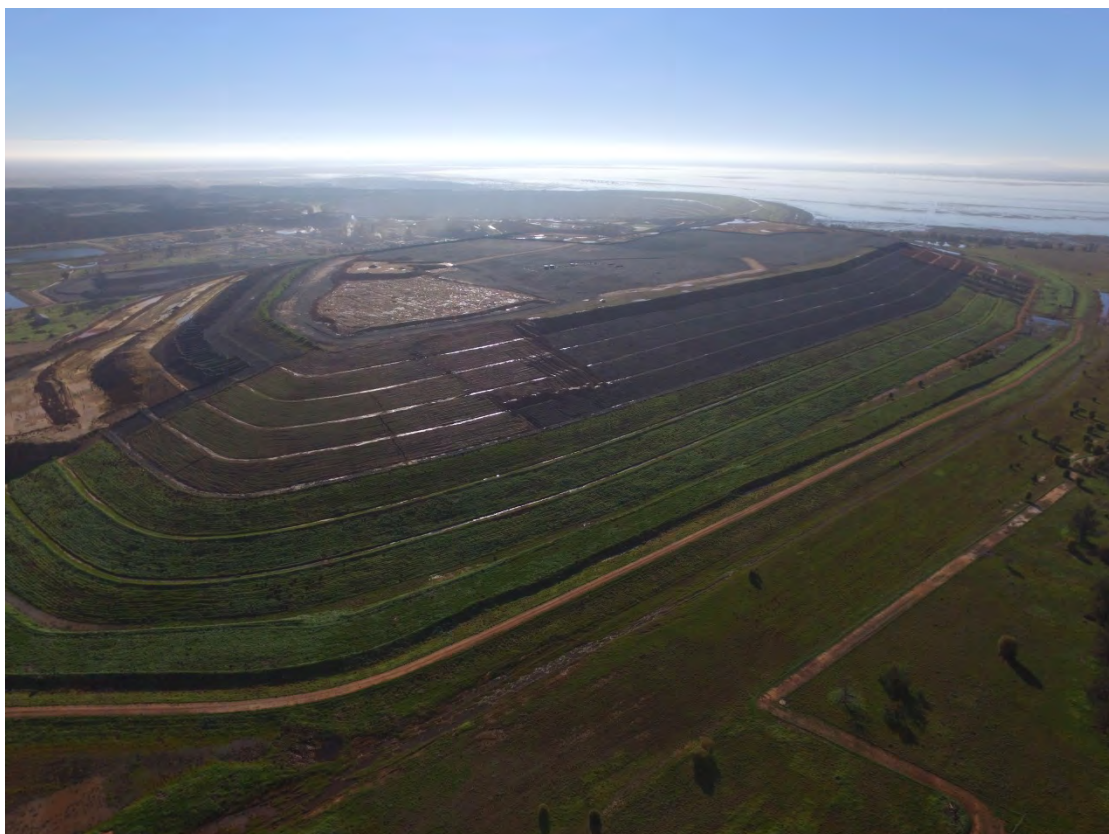
**Plate 3: South Side of Southern Waste Rock Emplacement (June 2016)**

An area of approximately 6 ha on the northern wall of the SWRE (Plate 6) was topsoiled during the reporting period. Along the south wall, rock mulch was applied to the upper five batters and topsoil placed at the top of the SWRE (from ROM 6) ready for placement. Gypsum application and direct seeding were to be conducted but rehabilitation activities were postponed during the reporting period as high rainfall prevented access to the SWRE batters.

Due to rain, some areas of the SWRE proposed for rehabilitation in the Cowal Gold Operations Mining Operations Plan (2014-2016) were unable to be completed. These areas are proposed for rehabilitation during the 2016-2018 MOP period.

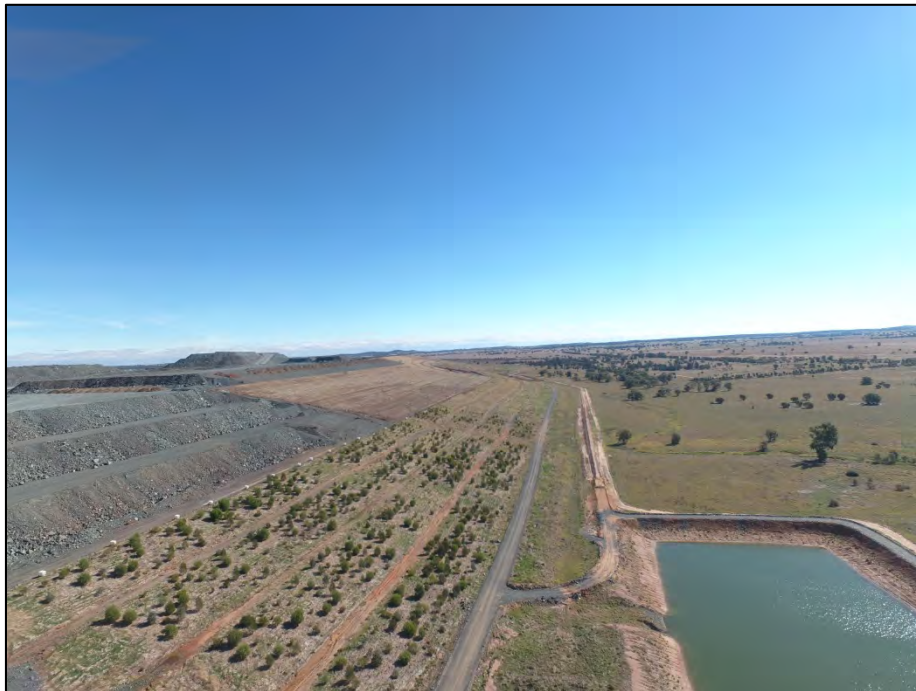
#### **Plate 4: NWRE – Pond D1 North Trial Tubestock (April 2016)**

The NWRE rehabilitation trial (Plate 7) aims to further assess the effectiveness of a variety of rehabilitation treatments or combination of treatments known to improve rehabilitation objectives in a replicated experimental design. The design has incorporated “standard” rehabilitation procedures such as a rock mulch underlay, topsoil and gypsum application which have proven to be essential components in the rehabilitation of saline, sodic and dispersive top soils and the extreme climatic conditions of the semi-arid Lake Cowal environment. These rehabilitation trials aim to determine if adequate rehabilitation outcomes can be obtained by reducing the depth of topsoil from the recommended 300 mm application whilst achieving a selection of primary ecological completion targets.

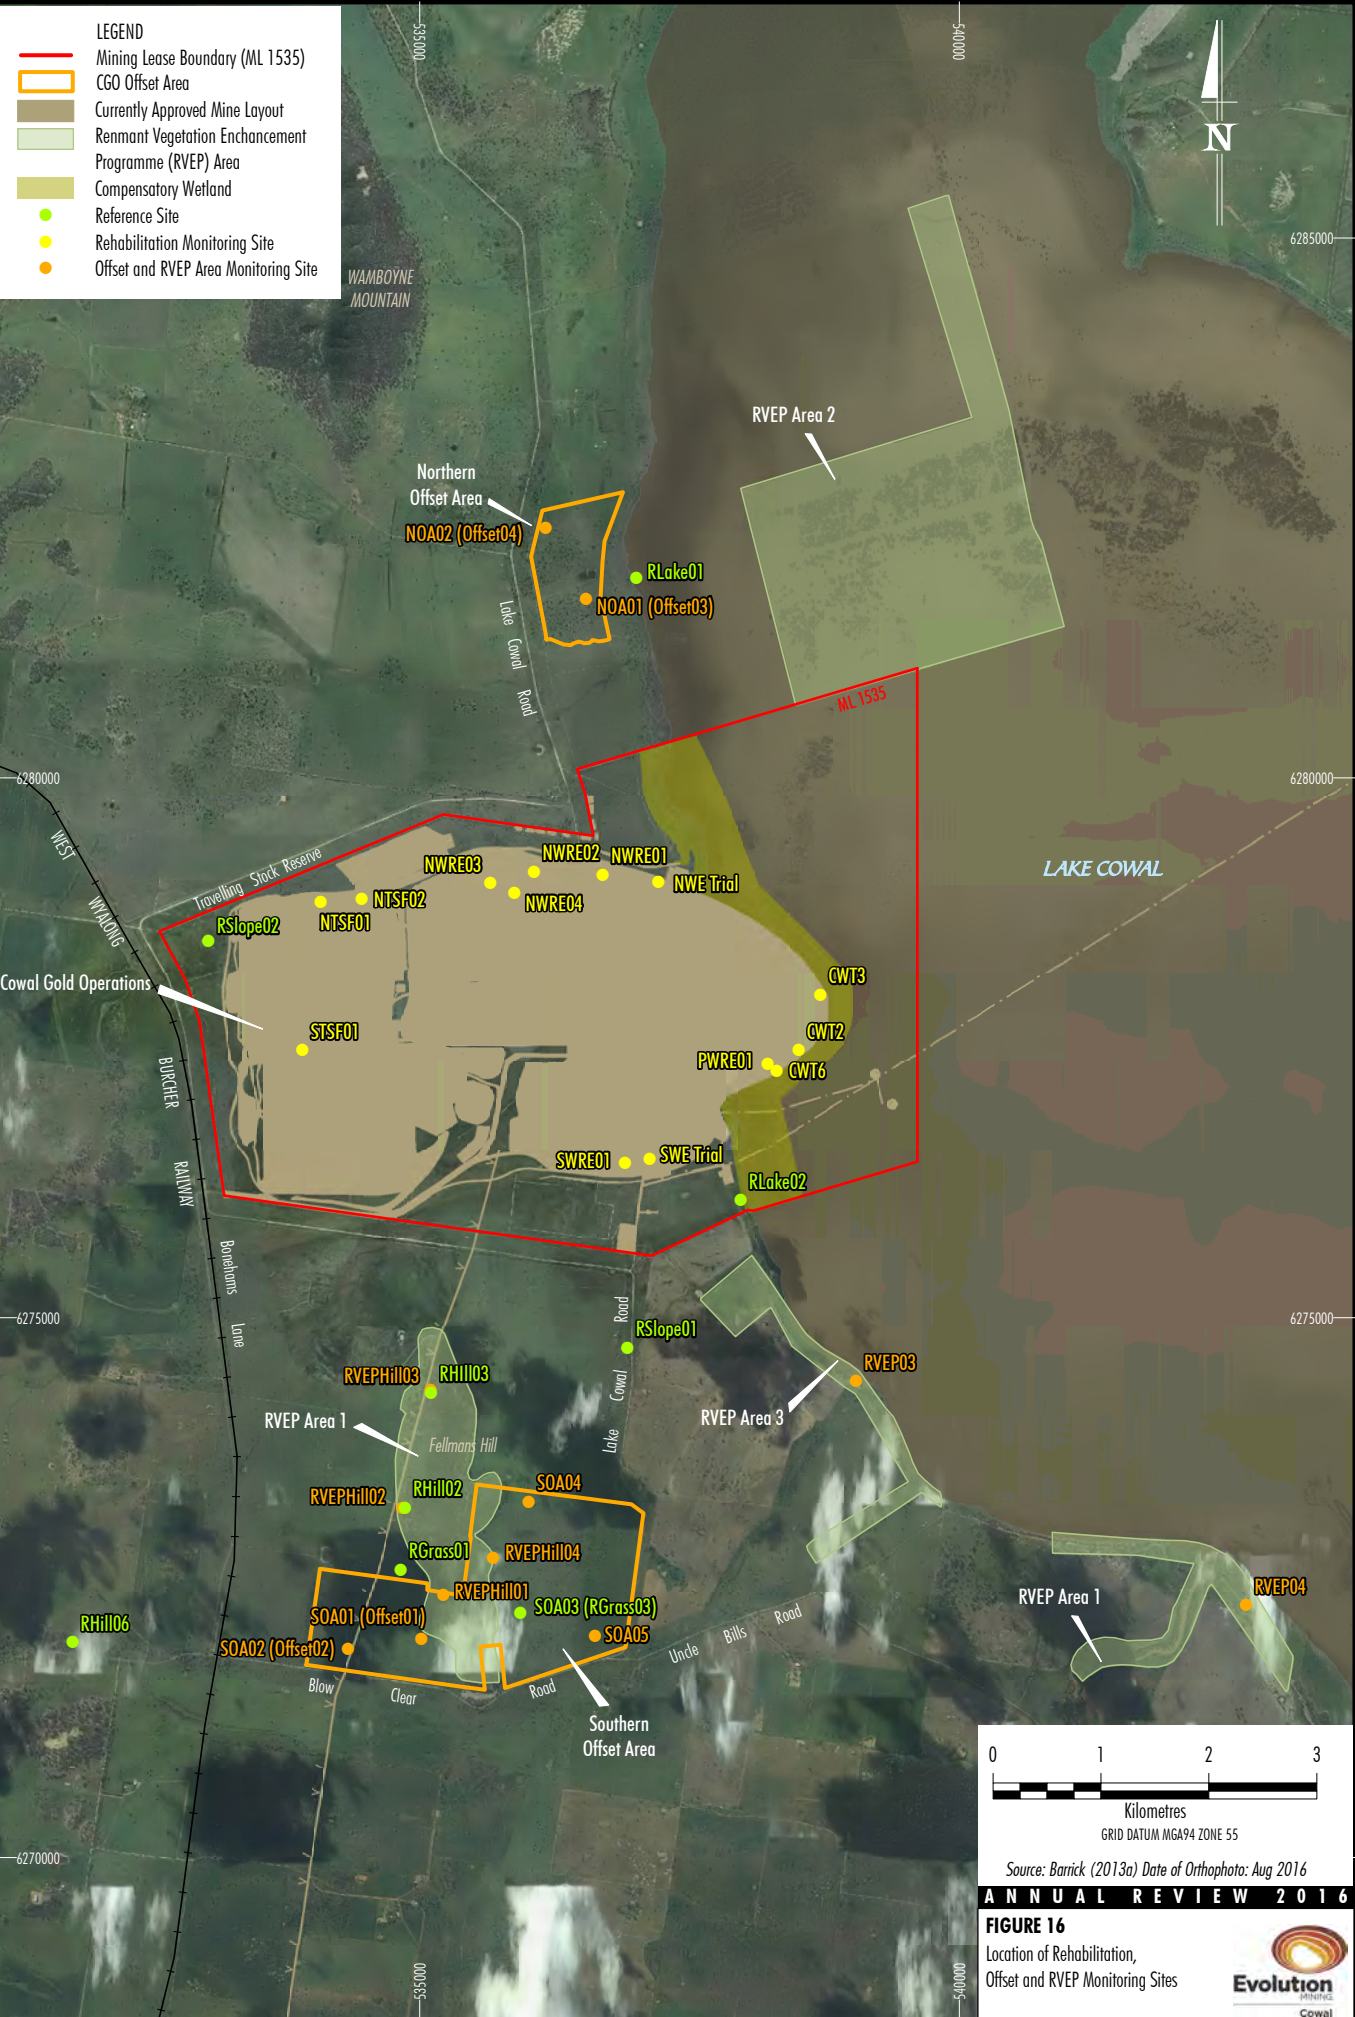
**FIGURE 15**  
Indicative location of Soil Stockpiles -  
December 2016

Source: Barrick (2013a) Date of Orthophoto: Aug 2016

Monitoring within the active rehabilitation areas was undertaken by DnA Environmental (2017a) during the reporting period. A summary of the results from this monitoring survey are outlined below. The indicative location of soil stockpiles and the location of rehabilitation, offset and RVEP monitoring sites are presented on Figures 15 and 16, respectively.
