COWAL GOLD OPERATIONS

2017 ANNUAL REVIEW

Name of Operation	<i>Cowal Gold Operations</i>
Name of Operator	<i>Evolution Mining (Cowal) Pty Limited</i>
Development Consent	<i>DA 14/98</i>
Name of Holder of Development Consent	<i>Evolution Mining (Cowal) Pty Limited</i>
Mining Lease #	<i>ML 1535</i>
Name of Holder of Mining Lease	<i>Evolution Mining (Cowal) Pty Limited</i>
Environmental Protection Licence #	<i>EPL11912</i>
Name of Holder of EPL	<i>Evolution Mining (Cowal) Pty Limited</i>
Water Licence #	<i>WAL 36569, WAL 31864, WAL 36615, WAL 36617, WAL 13749, WAL 14981, WAL 13748</i>
Name of Holder of Water Licences	<i>Evolution Mining (Cowal) Pty Limited</i>
MOP Start Date	<i>1 September 2016</i>
MOP End Date	<i>31 August 2018</i>
Annual Review Start Date	<i>1 January 2017</i>
Annual Review End Date	<i>31 December 2017</i>

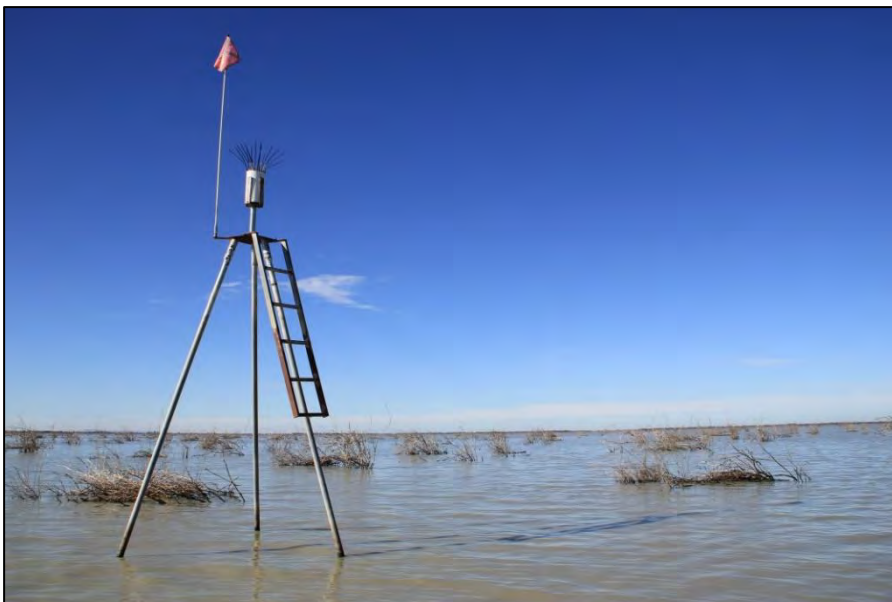
Plate 1: Elevated Depositional Dust Gauge within Lake Cowal

- Two of the five dust gauges within the ML 1535 area (DG11, DG12) recorded an annual average dust deposition above the assessment criterion. In the case of DG11, the exceedance was largely due to three dust deposits exceeding 10 g/m²/month between June and August, while for DG12, dust deposits exceeded 4 g/m²/month for nine of the 12 sampling periods. Levels recorded in the gauges inside the ML 1535 area are not relevant to the CGO Development Consent conditions.

¹ Of the 12 depositional dust gauges installed for the CGO during 2017, seven are located outside the ML 1535 boundary and, therefore, relevant to the assessment criterion for annual average deposited dust.

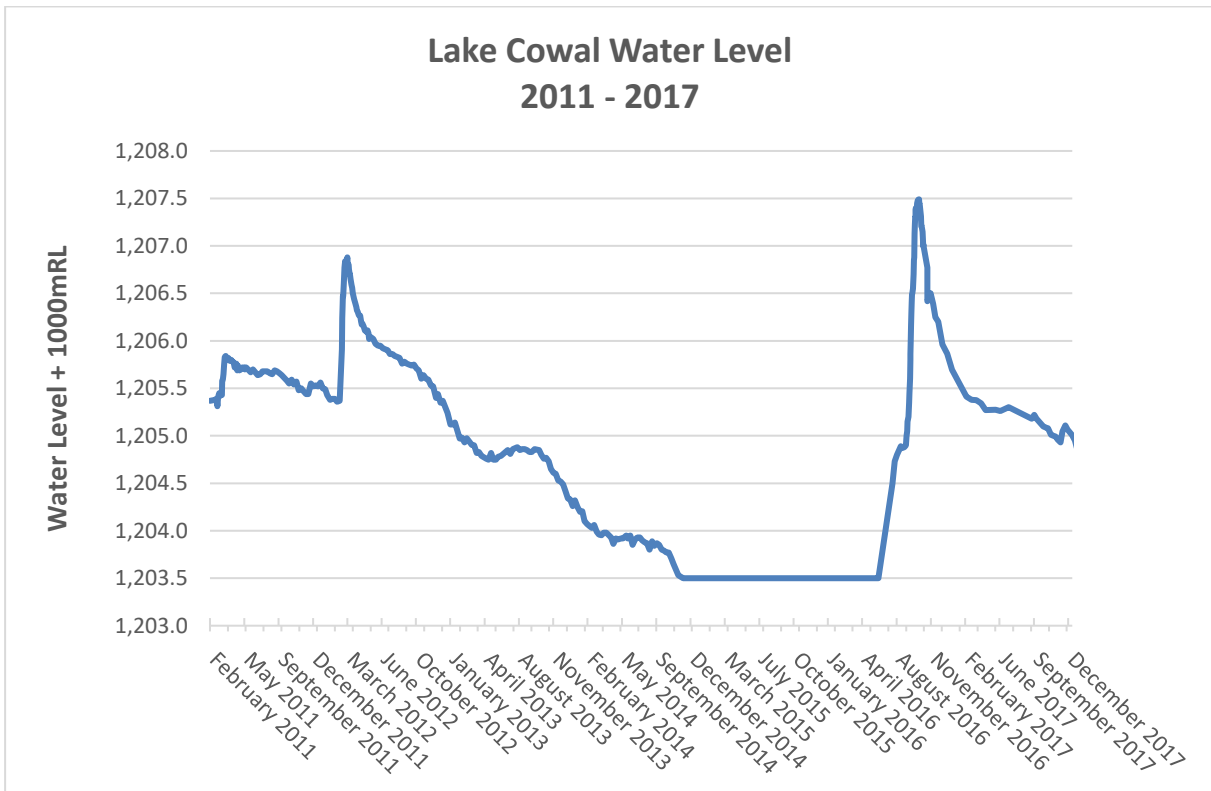
Graph 2: Lake Cowal Water Level 2011 - 2017

Lake Cowal peaked at a height of 207.49 m RL on 10 October 2016, before steadily receding back to 205.007 m RL by the end of 2017 (Graph 2).

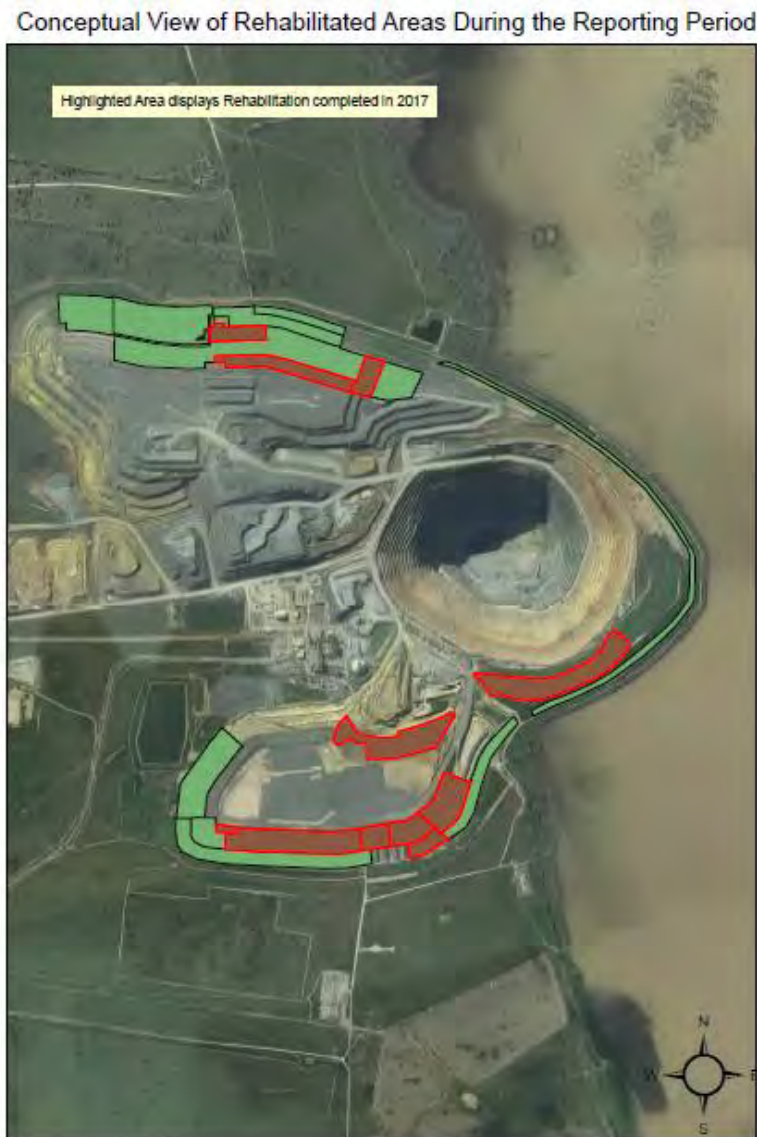
Plate 3: Conceptual View of Rehabilitated Areas During the Reporting Period

Table 26 provides details of the nature of disturbance and the rehabilitation status for areas that have been disturbed up to and including the reporting period. Plate 3 shows the areas rehabilitated during the reporting period.

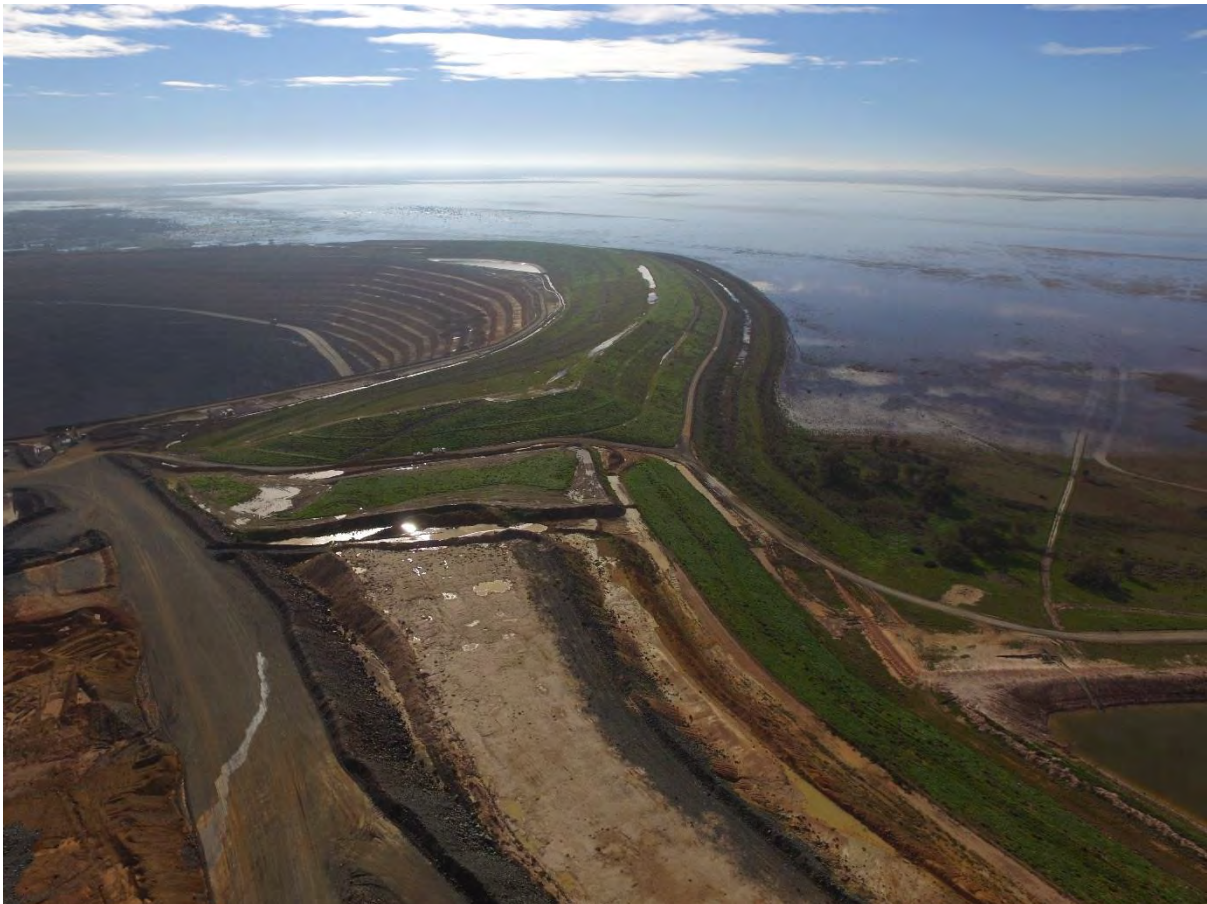
Plate 1: South Side of Perimeter Waste Rock Emplacement Prior to Stripping for Stage H

Approximately 7.8ha of the inner perimeter wall was shaped and covered with 300mm rock mulch in the reporting period (Plate 4).

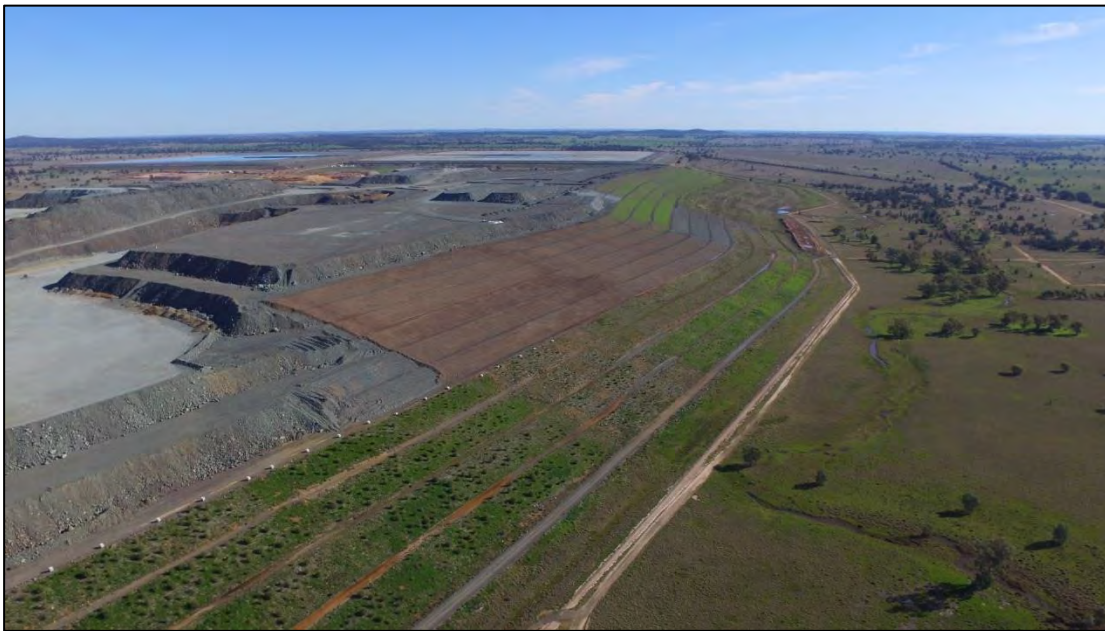
Plate 2: North Side of Northern Waste Rock Emplacement (June 2017)

The NWRE is approved to be constructed to approximately 308 m AHD and will occupy an area of approximately 269 ha northwest of the pit (Plate 5).

Tube stock was planted at the western end of the NWRE across all 12 batters, and were monitored during the reporting period.

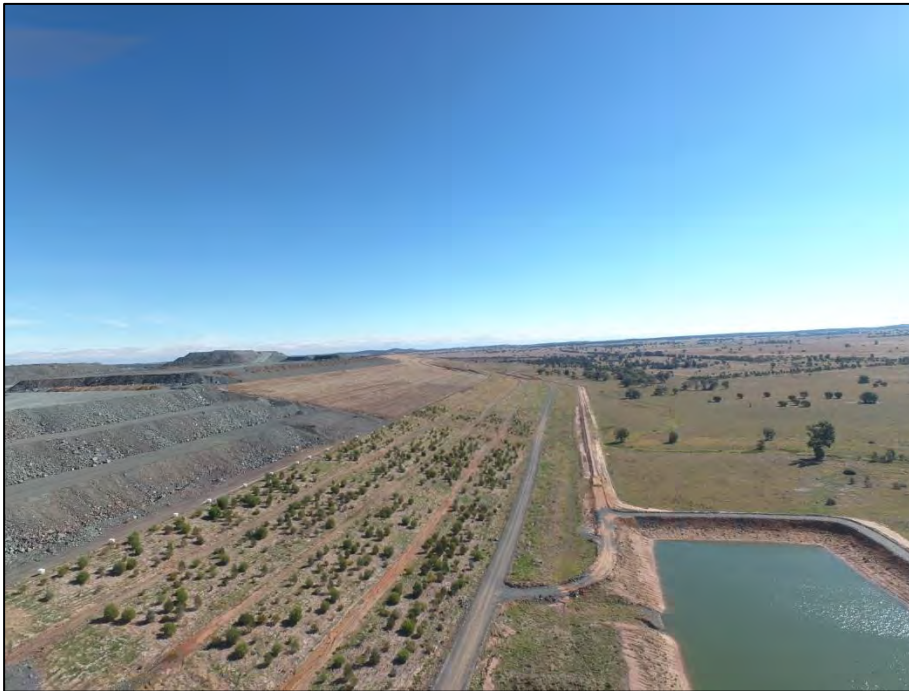
Plate 4: NWRE – Pond D1 North Trial Tubestock (April 2017)

The 2017 data has indicated that the density of trees and mature shrubs > 5cm dbh (and >2.0m in height) is greater on the older 2012/2013 trial area with one treatment (300Straw) already having comparable tree populations to the reference sites.

In the trial sites, average shrub and juvenile tree (<5cm dbh) densities ranged from a low of 442 (300Straw) to a high of 667 stems per hectare (14-300Straw), and all trial sites presently had stem densities comparable to the local hill woodlands.

The data has shown that the heavy application of straw and NPH mulches is likely to increase growth rates of the shrubs and juvenile trees on average but was not imperative for growth. The data to date has demonstrated that mulching can improve the growth rates of planted native tubestock, however the previous results have also shown that floristic diversity and perennial ground cover targets may be compromised, at least in the early development stages where mulch was applied thickly.

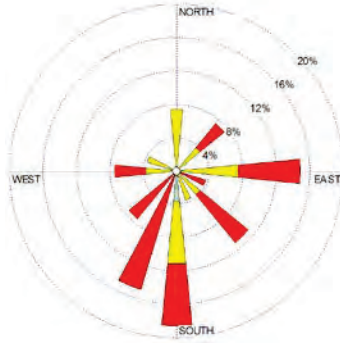
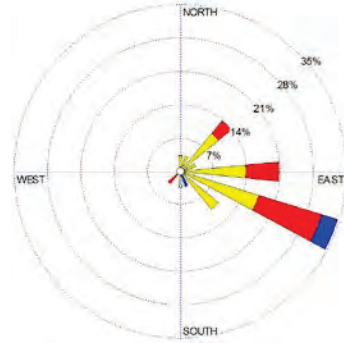
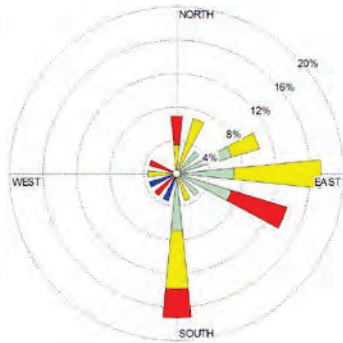
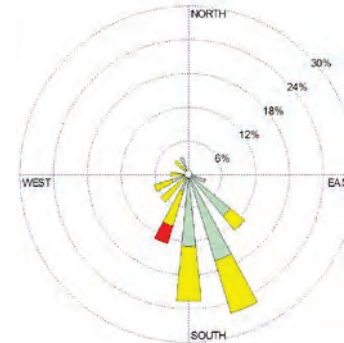
FIGURE 6b
Monthly Wind Roses for
January - December 2017

The CGO Automatic Weather Station (AWS) meteorological station located near the southern ML 1535 boundary, collected meteorological data throughout the reporting period. The station measures real-time wind speed and direction, standard deviation of wind direction, temperature (2 m, 10 m), barometric pressure, humidity, solar radiation and rainfall. The CGO AWS is supported by quarterly independent maintenance and calibration, as well as production of monthly data reviews by Sentinel Pty Ltd.

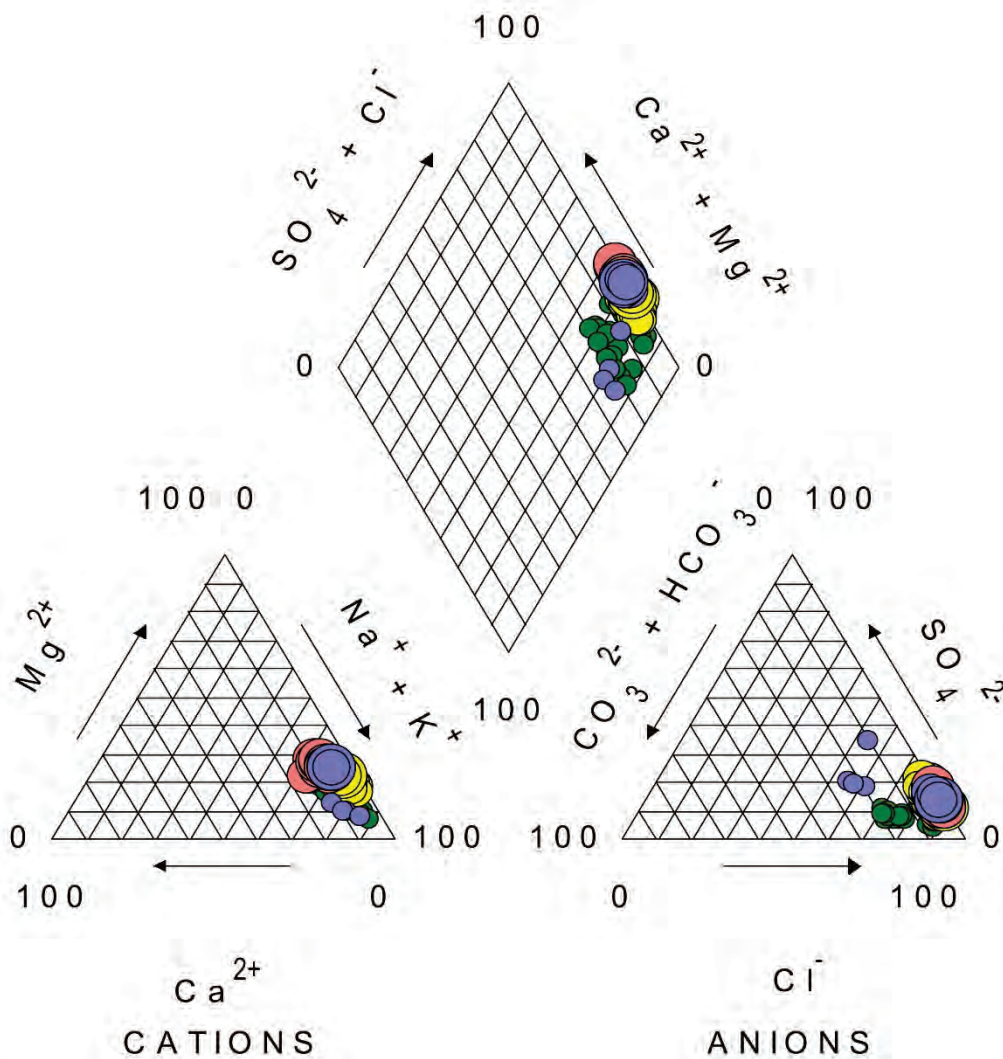
FIGURE 11b
Stiff Plots of Groundwater Chemistry
(Pit Area and Tailings Storage Facility)

- Bland Creek Palaeochannel Borefield
- Tailings Storage Areas
- Pit Area
- Processing Plant Area
