COWAL GOLD OPERATIONS

2018 ANNUAL REVIEW

Name of Operation	Cowal Gold Operations
Name of Operator	Evolution Mining (Cowal) Pty Limited
Development Consent	DA 14/98
Name of Holder of Development Consent	Evolution Mining (Cowal) Pty Limited
Mining Lease #	ML 1535
Name of Holder of Mining Lease	Evolution Mining (Cowal) Pty Limited
Environmental Protection Licence #	EPL11912
Name of Holder of EPL	Evolution Mining (Cowal) Pty Limited
Water Licence #	WAL 36569, WAL 31864, WAL 36615, WAL 36617, WAL 13749, WAL 14981, WAL 13748
Name of Holder of Water Licences	Evolution Mining (Cowal) Pty Limited
MOP Start Date (1)	1 September 2016
MOP End Date (1)	31 August 2018 (extended to 1 January 2019)
MOP Start Date (2)	1 January 2019
MOP End Date (2)	31 December 2019
Annual Review Start Date	1 January 2018
Annual Review End Date	31 December 2018

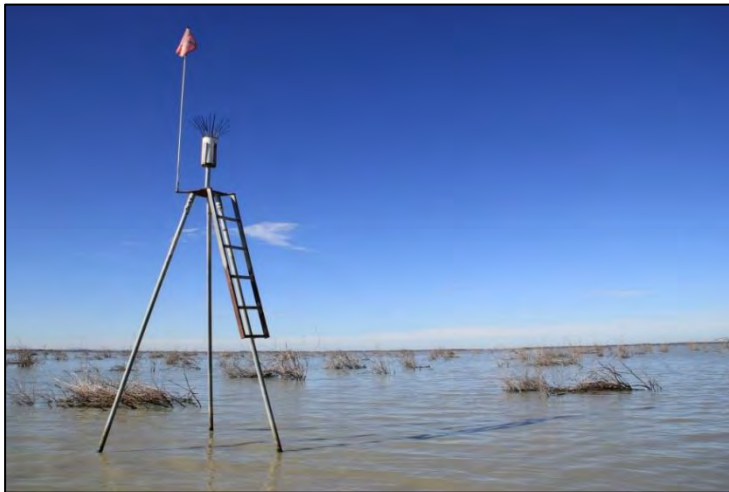
Plate 1: Elevated Depositional Dust Gauge within Lake Cowal

Temporal and spatial variation in reported monthly dust deposition was moderately strong during 2018. The average dust deposition rate across all gauges in 2018 was 4.1 g/m²/month, compared to 3.8 g/m²/month in 2017, 2.7 g/m²/month in 2015 and 2.8 g/m²/month in 2014. This larger average deposition rate for 2018 can be partially explained by increased dust storm activity in the region in 2018, as well as by the de-commissioning (in 2017, 2016) of some of the more remote dust gauges (from the mine), which have historically received low amounts of deposited dust, thus reducing the annual average of those earlier years. However, despite this the average dust deposition rate across all compliance gauges in 2018 was 4.0 g/m²/month.

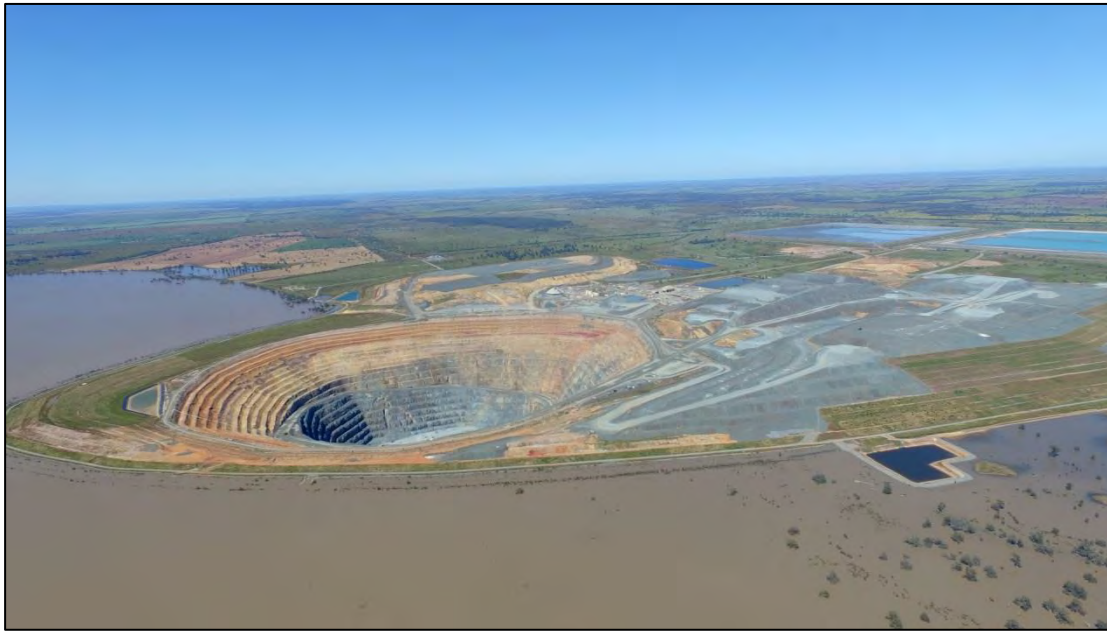
Plate 2: Aerial Photograph of the Lake Protection Bund

A comparison of the 2018 CGO lake sediment results against the ANZECC and ARMCANZ (2000) trigger values indicates the results were all below the recommended default trigger values, apart from total Antimony. These results are generally consistent with historical data.

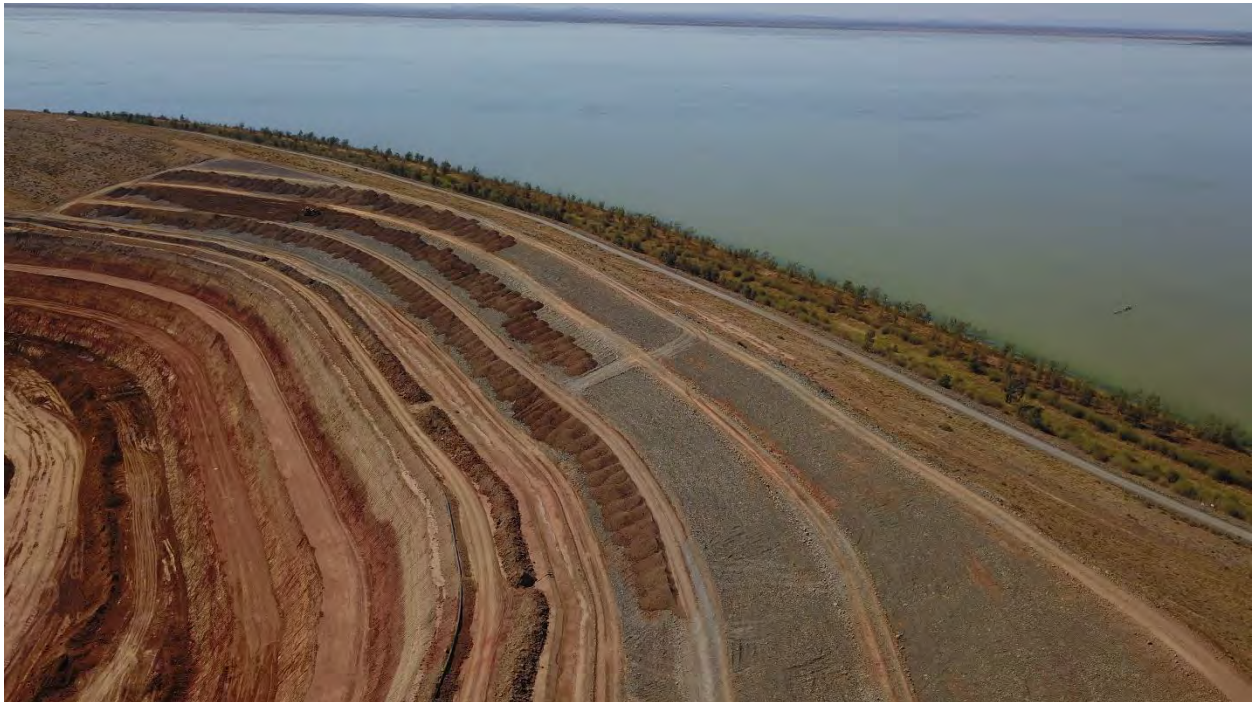
Plate 4: South Eastern Side of Perimeter Waste Rock Emplacement during Topsoil Movement 2018

Approximately 7.8ha of the inner perimeter wall was shaped and covered with 300mm topsoil was ripped, had gypsum spread and was direct seeded with native species in the reporting period (Plate 4).

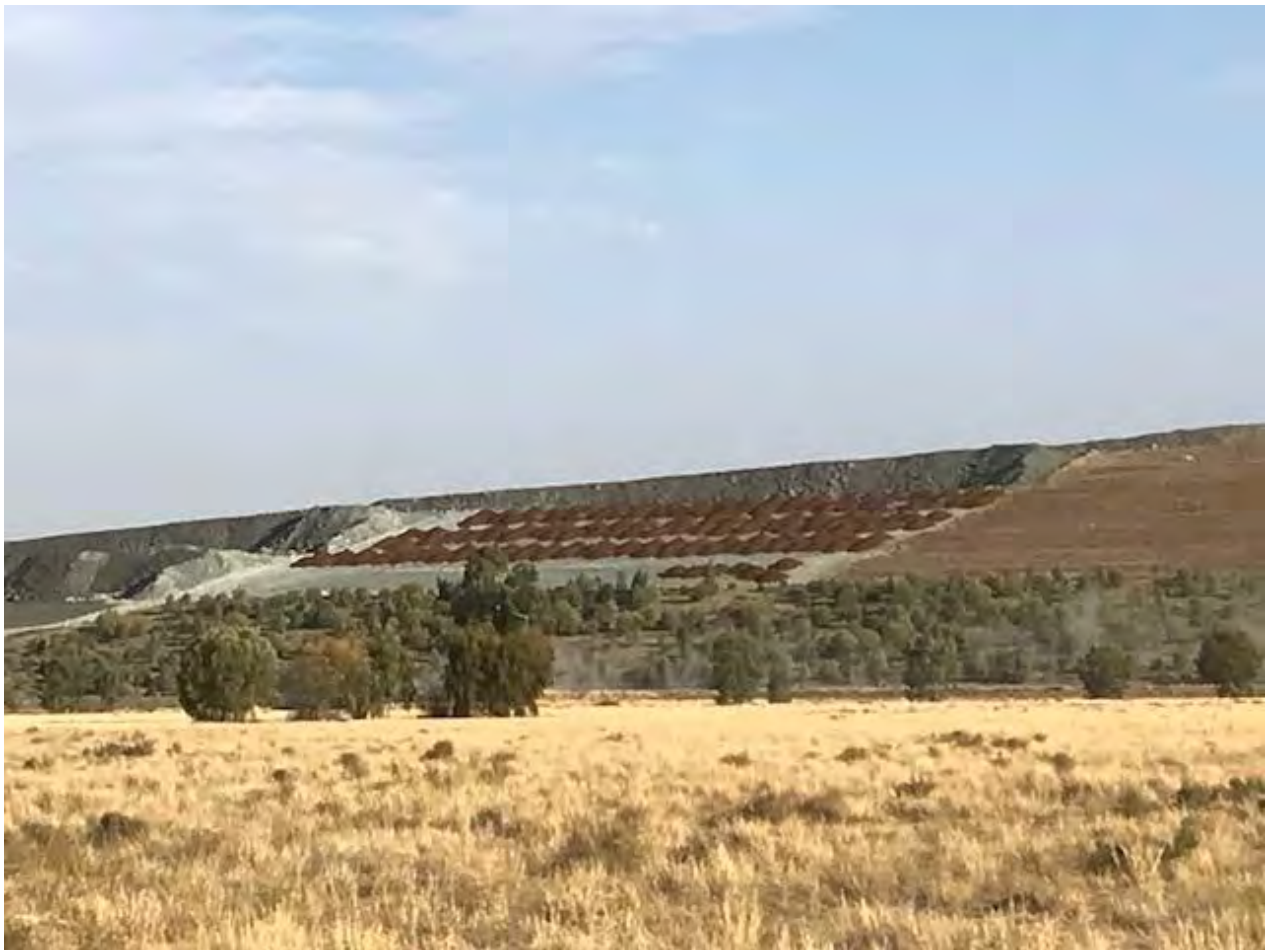
Plate 5: North Side of Northern Waste Rock Emplacement (April 2018)

The NWRE is approved to be constructed to approximately 308 m AHD and will occupy an area of approximately 269 ha northwest of the pit (Plate 5).

Tube stock planted in previous years on the NWRE was monitored during the reporting period.

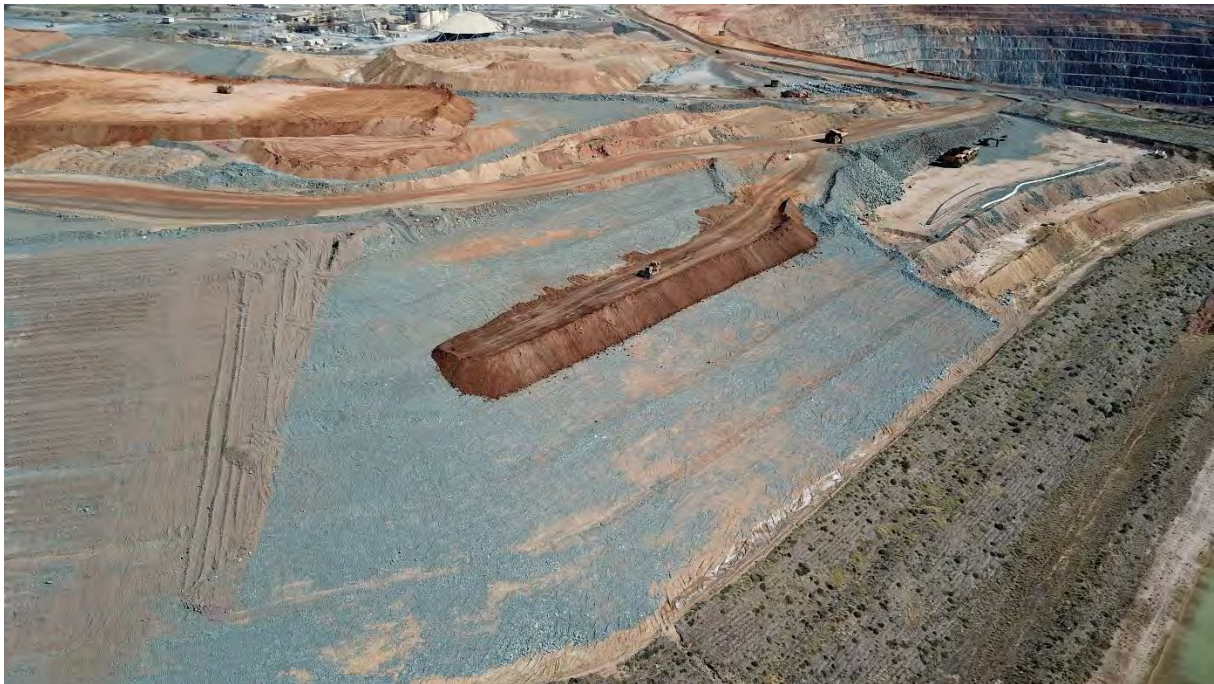
Plate 6: South East End of Southern Waste Rock Emplacement (February 2018)

Areas of approximately 5.3ha and an area of 4.1ha to the south east were shaped, rock mulch applied, topsoil applied and were direct seeded during the reporting period. Gypsum was also applied to these areas.

Due to rain in 2016, some areas of the SWRE proposed for rehabilitation in the MOP were unable to be completed in the 2016 reporting period. These areas were rehabilitated during the 2017 reporting period and seeded during the 2018 reporting period (Plate 6).

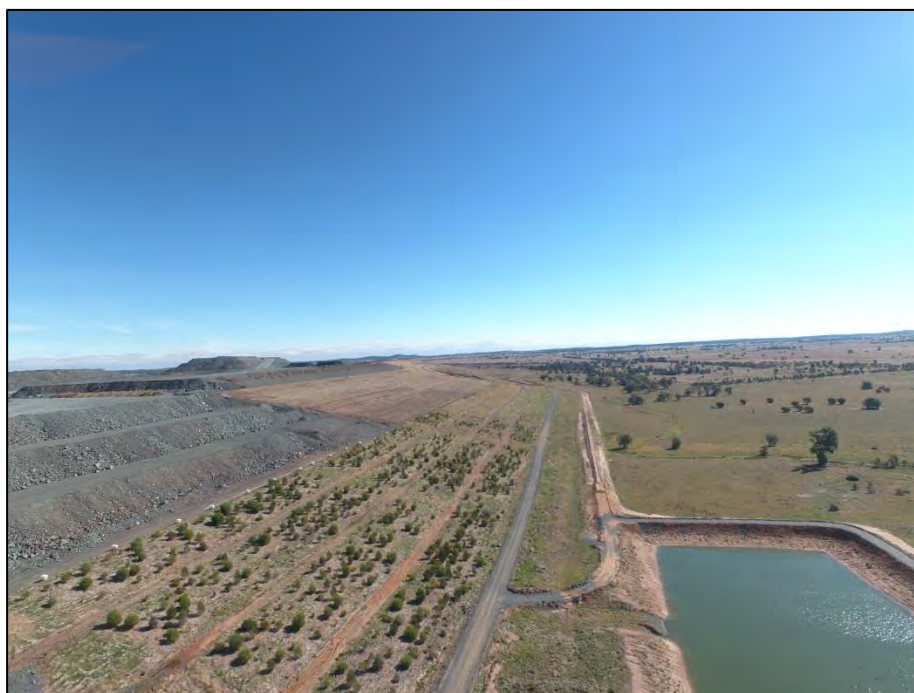
Plate 7: NWRE – Pond D1 North Trial Tubestock (April 2017)

These trials will continue during the next reporting period.
