COWAL GOLD OPERATIONS

2019 ANNUAL REVIEW

Name of Operation	<i>Cowal Gold Operations</i>
Name of Operator	<i>Evolution Mining (Cowal) Pty Limited</i>
Development Consent	<i>DA 14/98</i>
Name of Holder of Development Consent	<i>Evolution Mining (Cowal) Pty Limited</i>
Mining Lease #	<i>ML 1535</i>
Name of Holder of Mining Lease	<i>Evolution Mining (Cowal) Pty Limited</i>
Mining Lease #	<i>ML 1791</i>
Name of Holder of Mining Lease	<i>Evolution Mining (Cowal) Pty Limited</i>
Environmental Protection Licence #	<i>EPL11912</i>
Name of Holder of EPL	<i>Evolution Mining (Cowal) Pty Limited</i>
Water Licence #	<i>WAL 36569, WAL 31864, WAL 36615, WAL 36617, WAL 13749, WAL 14981, WAL 13748, WAL 13748, WAL 31568, WAL 31563, WAL 42993</i>
Name of Holder of Water Licences	<i>Evolution Mining (Cowal) Pty Limited</i>
MOP Start Date (1)	<i>1 January 2019</i>
MOP End Date (1)	<i>31 December 2019 extended to 30 June 2020)</i>
MOP End Date (2)	<i>31 December 2019</i>

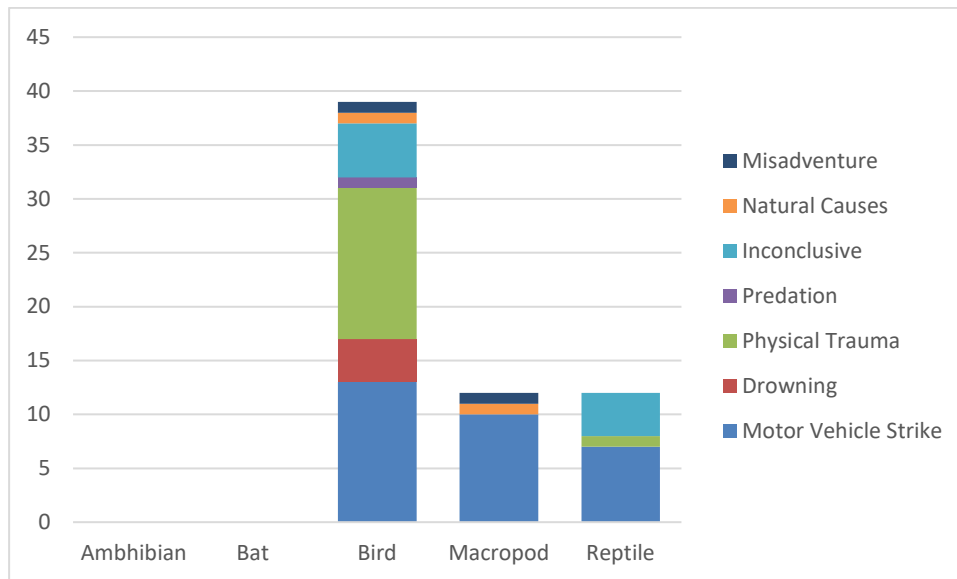
Graph 1: Graph of Fauna Deaths for the Reporting Period

There were a total of 61 fauna incidents on ML 1535 during the reporting period. All injured or deceased fauna were taken to the local vet for examination as required (i.e. in instances where cause of death cannot be immediately determined). Motor vehicle strike was the most prominent cause of death during the reporting period (Graph 1). There were no cyanide related fauna incidents or deaths.

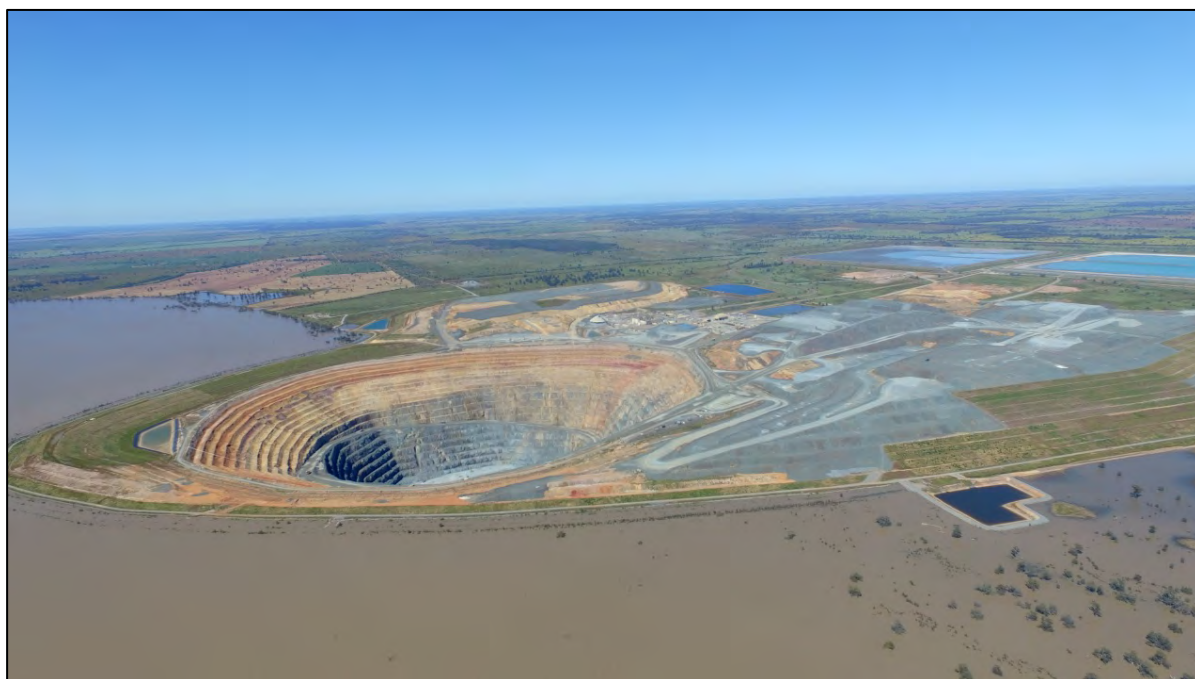
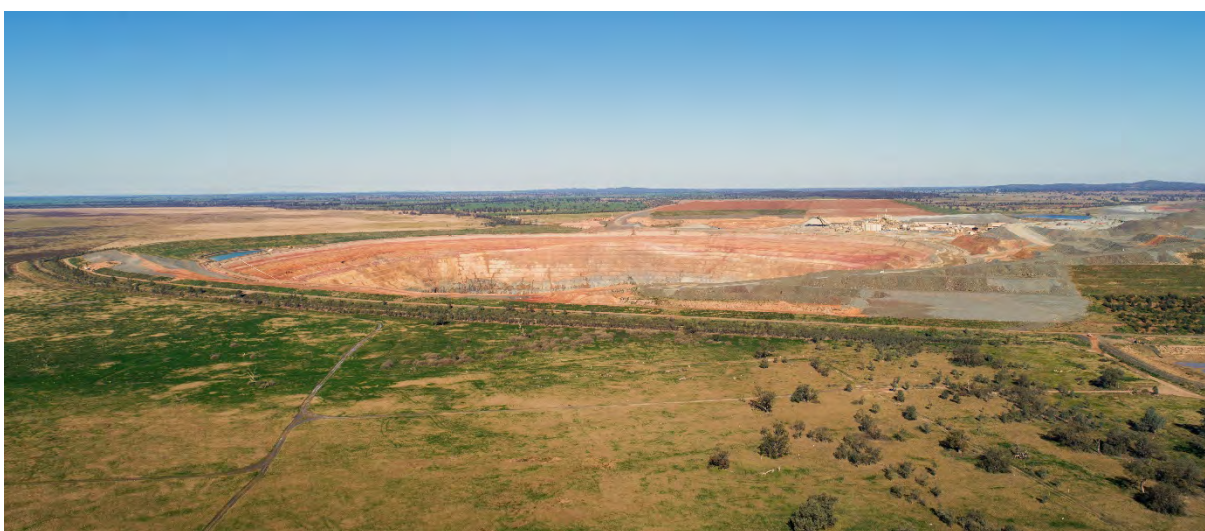
Plate 2: Aerial Photograph of the Lake Protection Bund

During the reporting period, Lake Cowal was predominantly dry with the lake receding to dry by mid-February, no samples were taken during this period as a result.

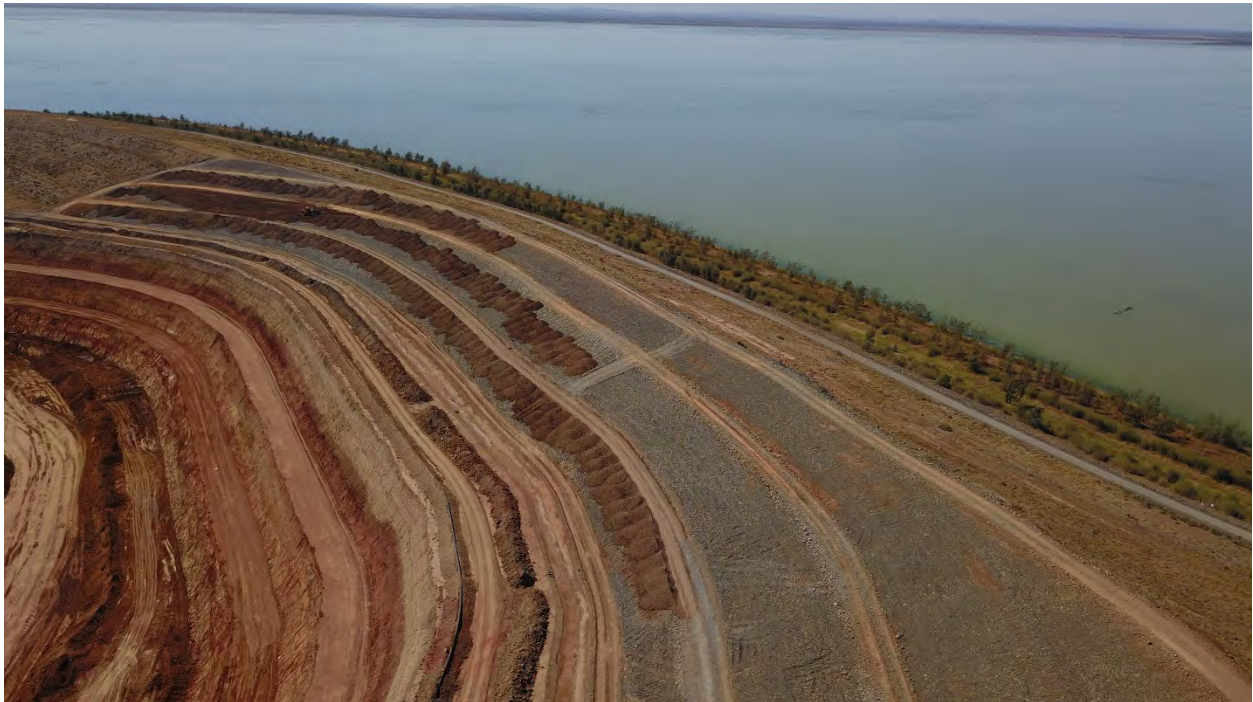
Plate 4: South Eastern Side of Perimeter Waste Rock Emplacement during Topsoil Movement 2018

Approximately 7.8ha of the inner perimeter wall was re-ripped in the reporting period due to lack of covers from prolonged dry periods and wind/splash erosion was corrected (Plate 4).

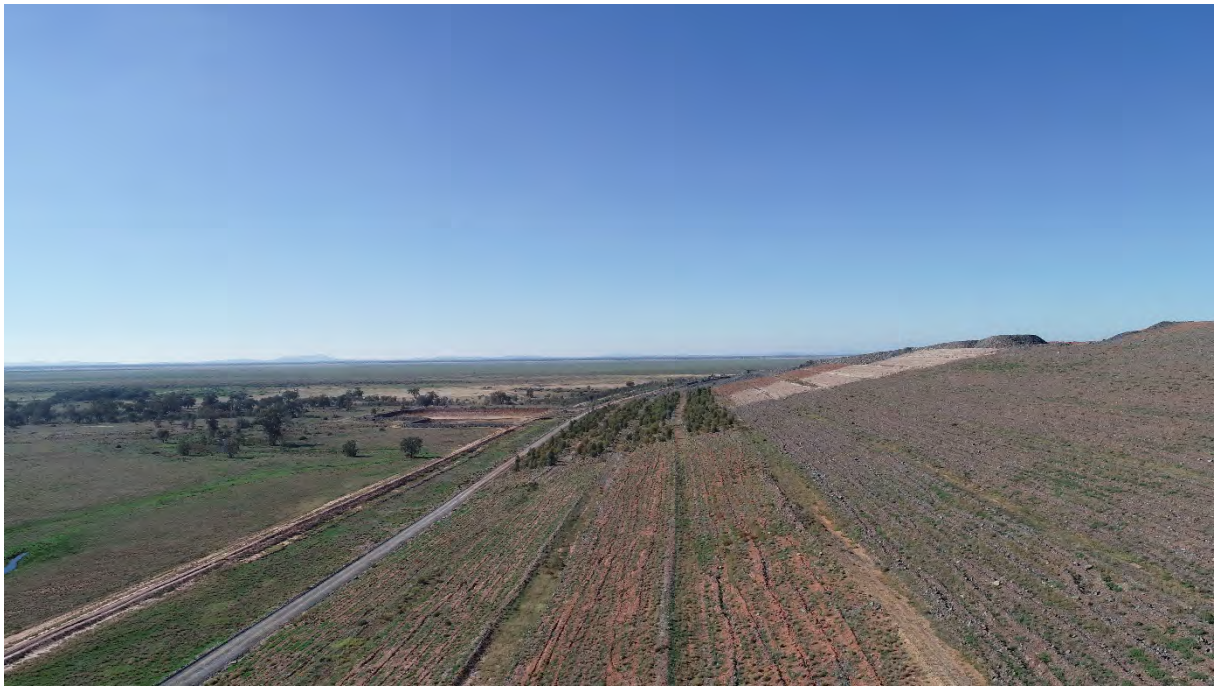
Plate 5: North Side of Northern Waste Rock Emplacement (May 2019)

The NWRE is approved to be constructed to approximately 308 m AHD and will occupy an area of approximately 269 ha northwest of the pit (Plate 5).

Tube stock planted in previous years on the NWRE was monitored during the reporting period.

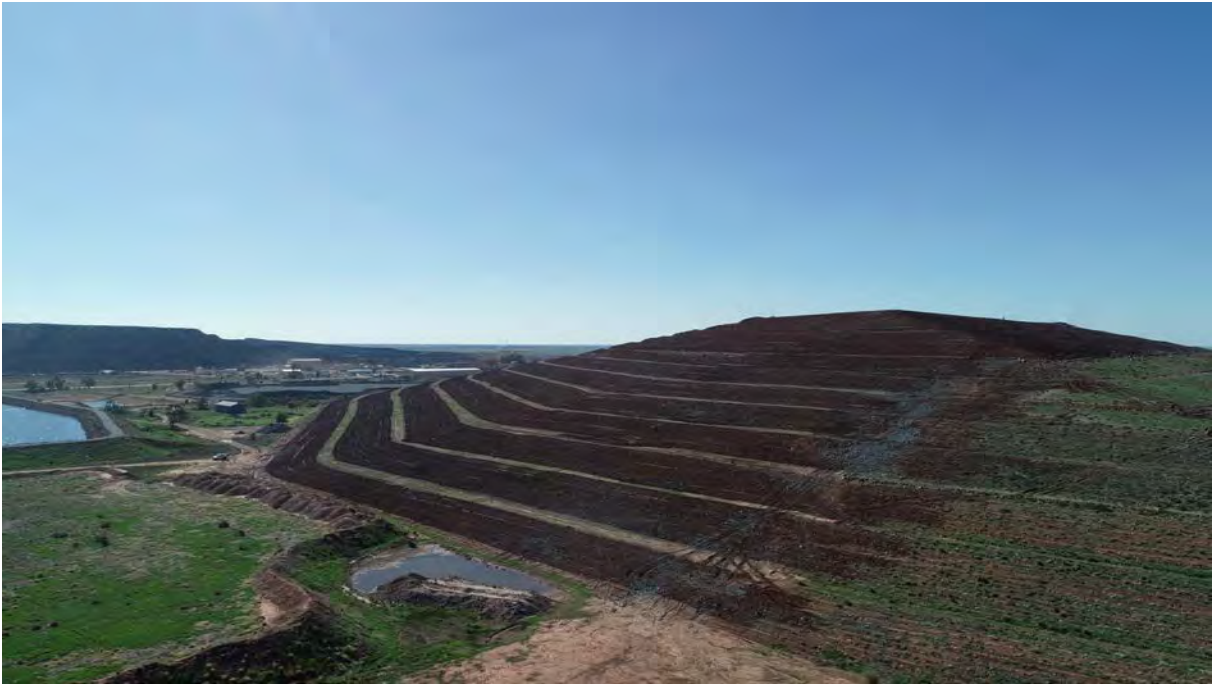
Plate 6: West End of Southern Waste Rock Emplacement (May 2019)

Area of approximately 5ha on the south side of the SWRE upper batters and areas of 3.7ha and 9.5ha on the west side of the SWRE lower, mid and upper batters were rock armoured, topsoiled, gypsum spread and were direct seeded via aerial application during the reporting period.

Approximately 37.5ha was also re ripped and direct seeded with native species in the previous reporting period and continued to be monitored during this reporting period.

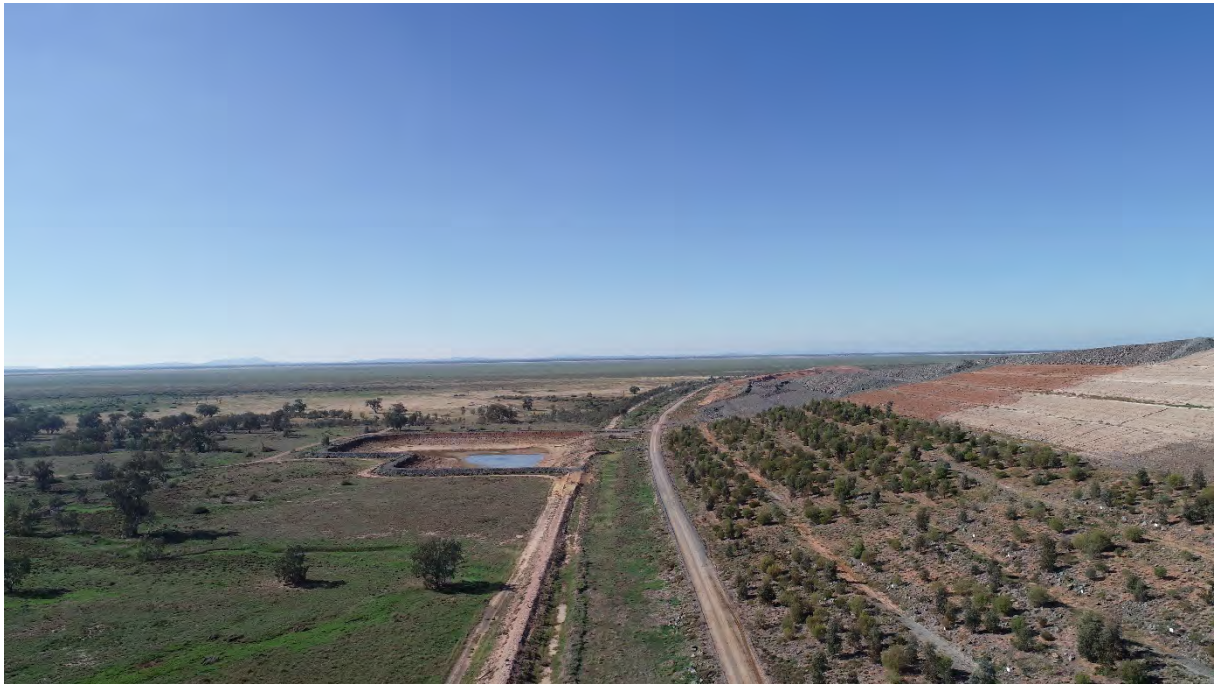
Plate 7: NWRE – Pond D1 North Trial Tubestock (May 2019)

These trials will continue during the next reporting period.
