# **Cowal Gold Operations Open Pit Continuation Project**

## **Contamination Preliminary Site Investigation**

Prepared for Evolution Mining (Cowal) Pty Limited

April 2023

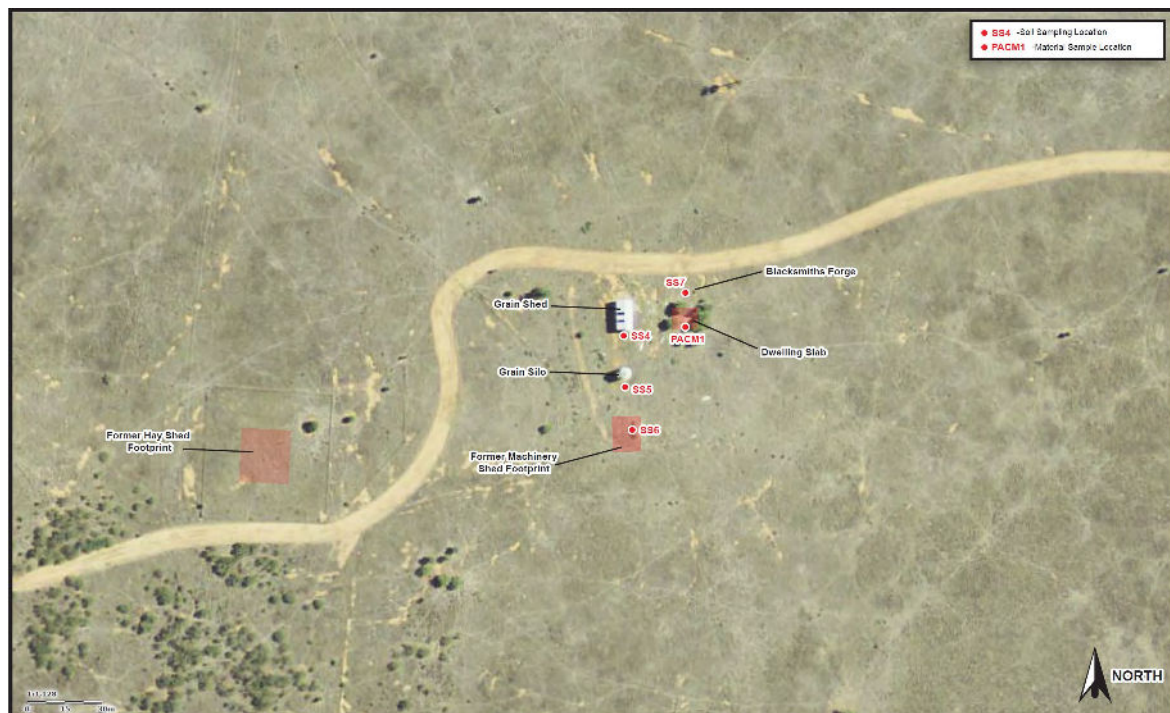
**Figure 3.2** Potential areas of environmental concern detailing structures from the former dwelling

- asbestos was detected from the fibro cladding material, indicating that the surface soil around the former dwelling might contain asbestos
- zinc was observed above the Ecological Investigation Levels (EILs) outlined in the NEPM (2013) of 70 mg/kg but were less than the human health threshold. These concentrations were not considered significant.

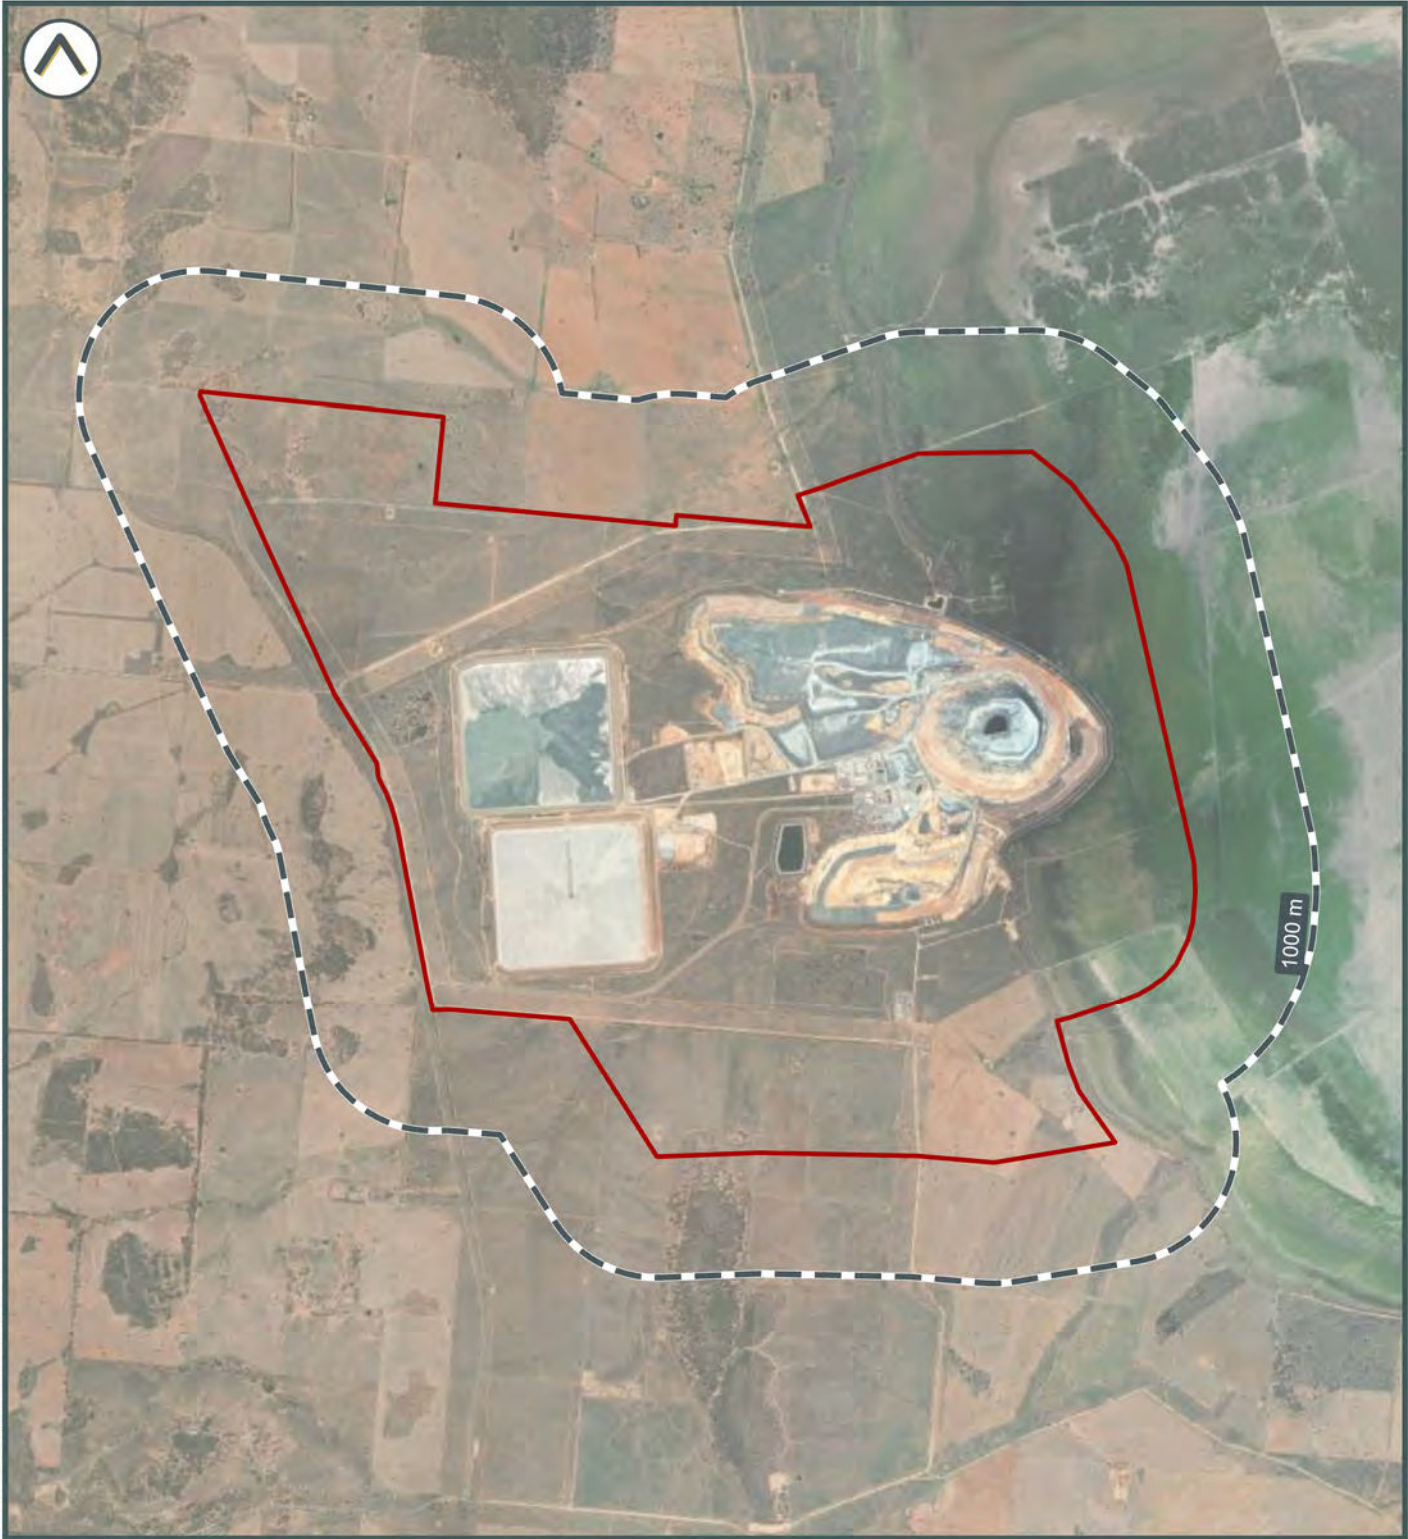
- Subject area
- Contaminated Land Public Register (EPA)
- EPA Notified Contaminated Sites
- EPA Record of Notices

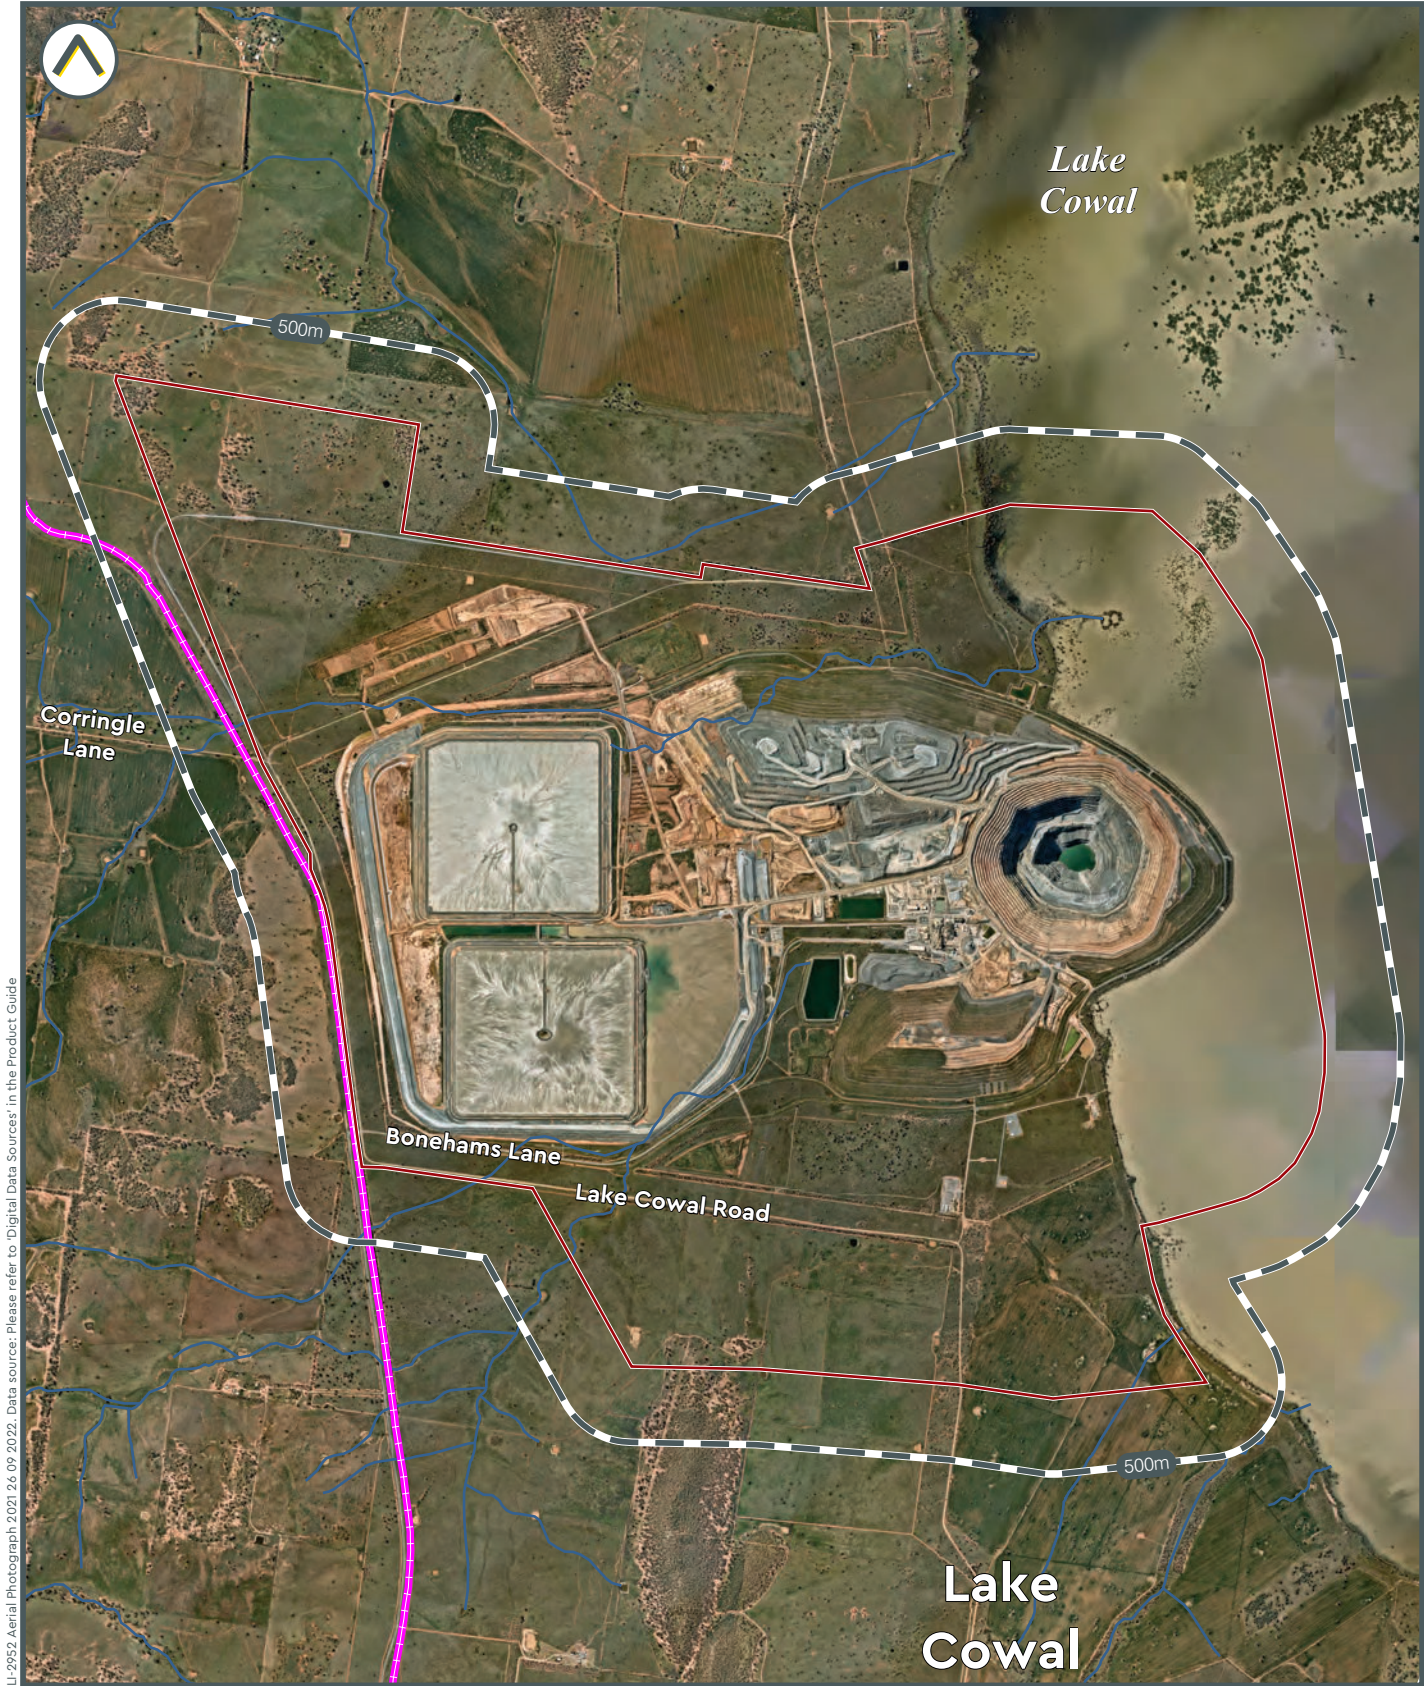
Historic Aerial Photograph - 2021

LI-2952 Aerial Photograph 2021 26.09.2022. Data source: Please refer to 'Digital Data Sources' in the Product Guide
