# **COWAL GOLD OPERATIONS**

## **2021 ANNUAL REVIEW**

<b>Name of Operation</b>	<i>Cowal Gold Operations</i>
<b>Name of Operator</b>	<i>Evolution Mining (Cowal) Pty Limited</i>
<b>Development Consent</b>	<i>DA 14/98 and SSD 10367</i>
<b>Name of Holder of Development Consent</b>	<i>Evolution Mining (Cowal) Pty Limited</i>
<b>Mining Lease #</b>	<i>ML 1535</i>
<b>Name of Holder of Mining Lease</b>	<i>Evolution Mining (Cowal) Pty Limited</i>
<b>Mining Lease #</b>	<i>ML 1791</i>
<b>Name of Holder of Mining Lease</b>	<i>Evolution Mining (Cowal) Pty Limited</i>
<b>Environmental Protection Licence #</b>	<i>EPL11912</i>
<b>Name of Holder of EPL</b>	<i>Evolution Mining (Cowal) Pty Limited</i>
<b>Water Licence #</b>	<i>WAL 36569, WAL 31864, WAL 36615, WAL 36617, WAL 13749, WAL 14981, WAL 13748, WAL 13748, WAL 31568, WAL 31563, WAL 42993</i>
<b>Name of Holder of Water Licences</b>	<i>Evolution Mining (Cowal) Pty Limited</i>
<b>MOP Start Date</b>	<i>1 October 2021</i>

<b>MOP End Date</b>	<i>2 July 2022</i>
<b>Annual Review Start Date</b>	<i>1 January 2021</i>
<b>Annual Review End Date</b>	<i>31 December 2021</i>

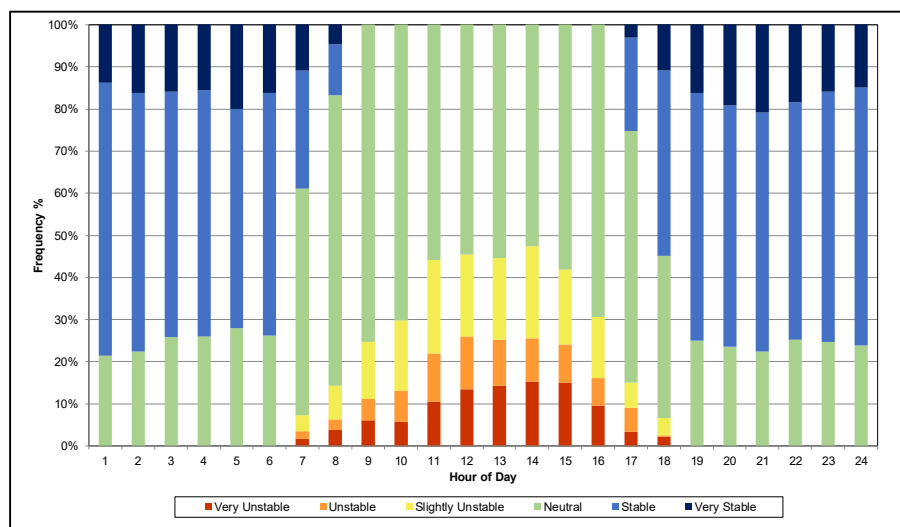
**Graph 1: Diurnal variation in stability for CGO during 2021**

Atmospheric stability for 2021 has been calculated using the AWS meteorological data collected, and Graph 1 presents the diurnal variation in atmospheric stability at Cowal. The profile shows that atmospheric instability increases during the daylight hours as the sun generated convective energy increases, whereas stable atmospheric conditions prevail during the night-time. This profile indicates that the potential for effective atmospheric dispersion of emissions would be greatest during day-time hours and lowest during evening through to early morning hours (Zephyr Environmental, 2022).

Atmospheric stability refers to the degree of turbulence or mixing that occurs within the atmosphere and is a controlling factor in the rate of atmospheric dispersion of dust from mining operations (Zephyr Environmental, 2022). Highly stable conditions lead to poor dispersion while unstable conditions enable more effective dispersion of pollutants.

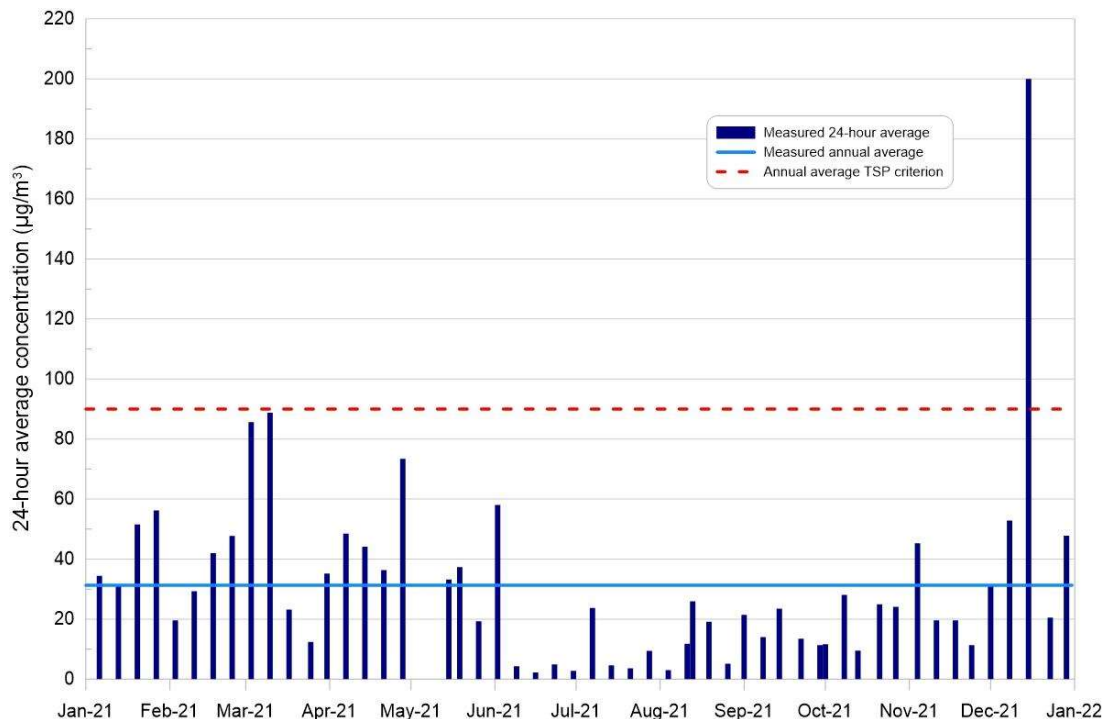
**Graph 2: TSP masses measured at the Coniston Homestead during 2021.**

The measurements of TSP, taken by the HVAS on a (generally) seven-day cycle, are shown below in Graph 2. While there are individual elevated concentrations, the annual average calculated from 54 measurements (31.3 µg/m<sup>3</sup>) was well below the annual average TSP criterion of 90 µg/m<sup>3</sup>. The highest concentration of 200 µg/m<sup>3</sup>, measured on 15 December, was recorded during a local dust storm after significant wind gusts of up to 70 km/h.

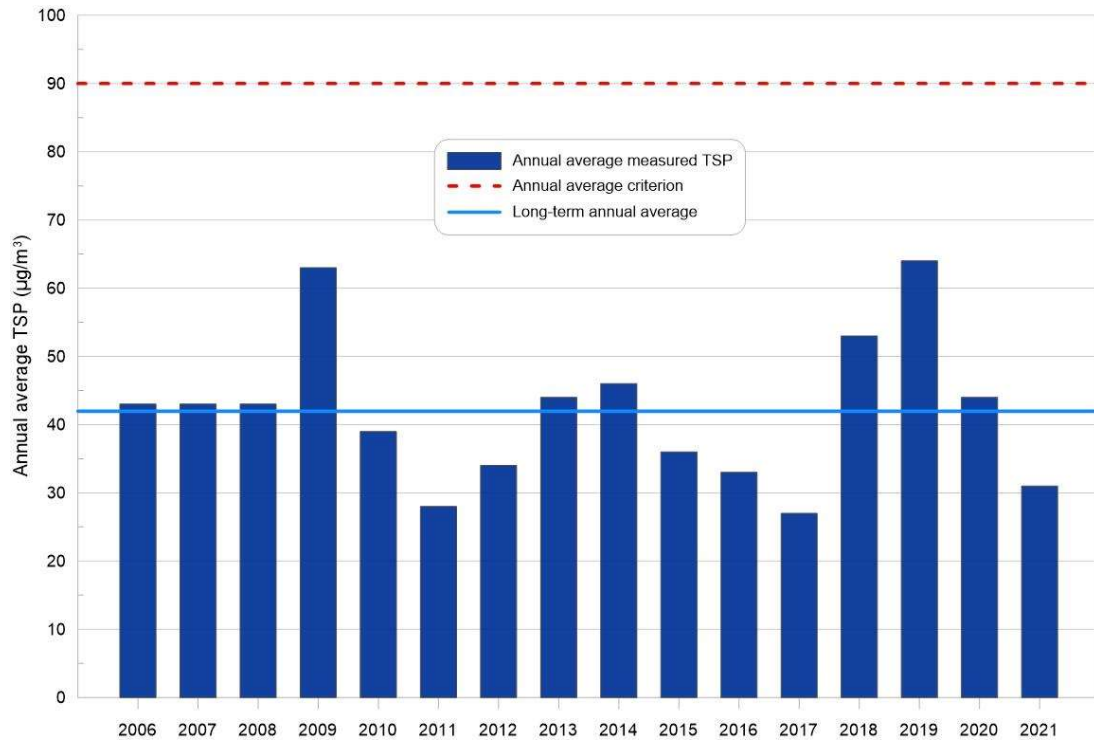
**Graph 3: Annual average TSP concentrations – 2006 to 2021**

The historical annual average TSP measurements from 2006 to 2021 are displayed in Graph 3. The annual average TSP concentrations for 2021 are not only below the assessment criterion, but also well below the long-term average for the site of 42 µg/m<sup>3</sup>. This indicates that the concentrations are influenced by external factors, such as drought, with high annual averages in years following significant drought (2009 and 2019), and much lower concentrations in wetter years.

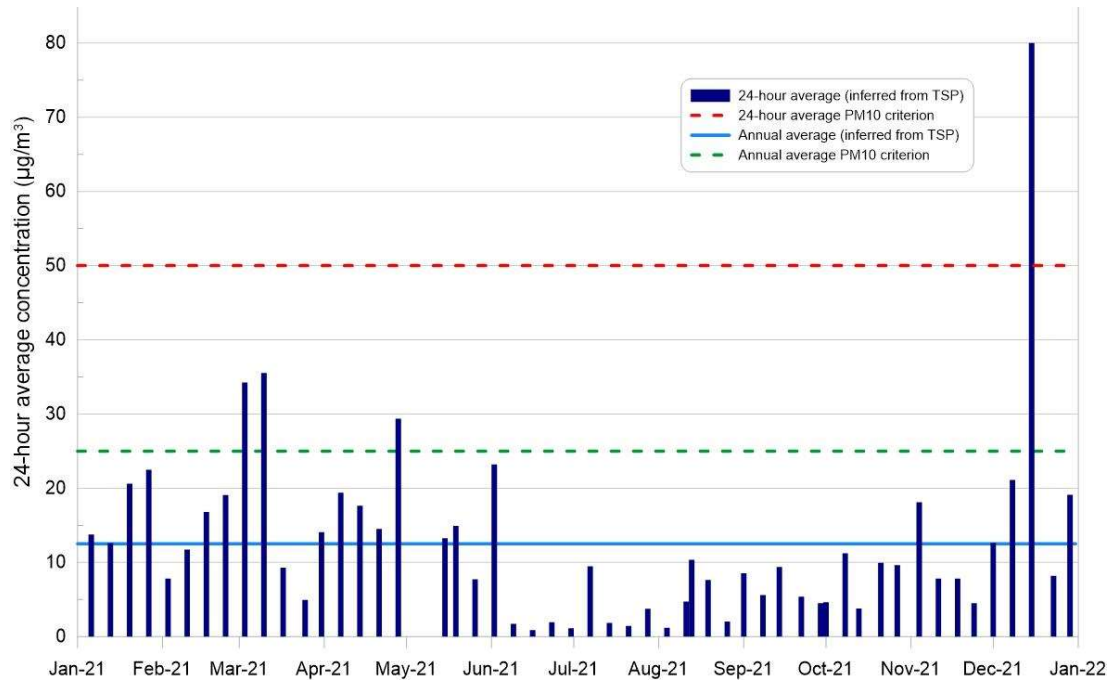
**Graph 4: PM10 data inferred from TSP measurements – 2021**

As described in the *Cowal Gold Mine Extension Modification Air Quality Impact Assessment* undertaken by Pacific Environment Limited (PEL) (2013), PM<sub>10</sub> can be calculated as 40% of measured TSP (NSW Minerals Council, 2000). All 'inferred' annual average PM<sub>10</sub> concentrations remain below the 24-hour average criterion (Graph 4), except for the aforementioned dust storm recorded on 15 December. Despite this, the annual average of 12.5 µg/m<sup>3</sup> remained well below the annual criterion of 25 µg/m<sup>3</sup>. The 'inferred' annual average PM<sub>10</sub> concentration was also well below the long-term average of 16.8 µg/m<sup>3</sup>, as shown in Graph 5.

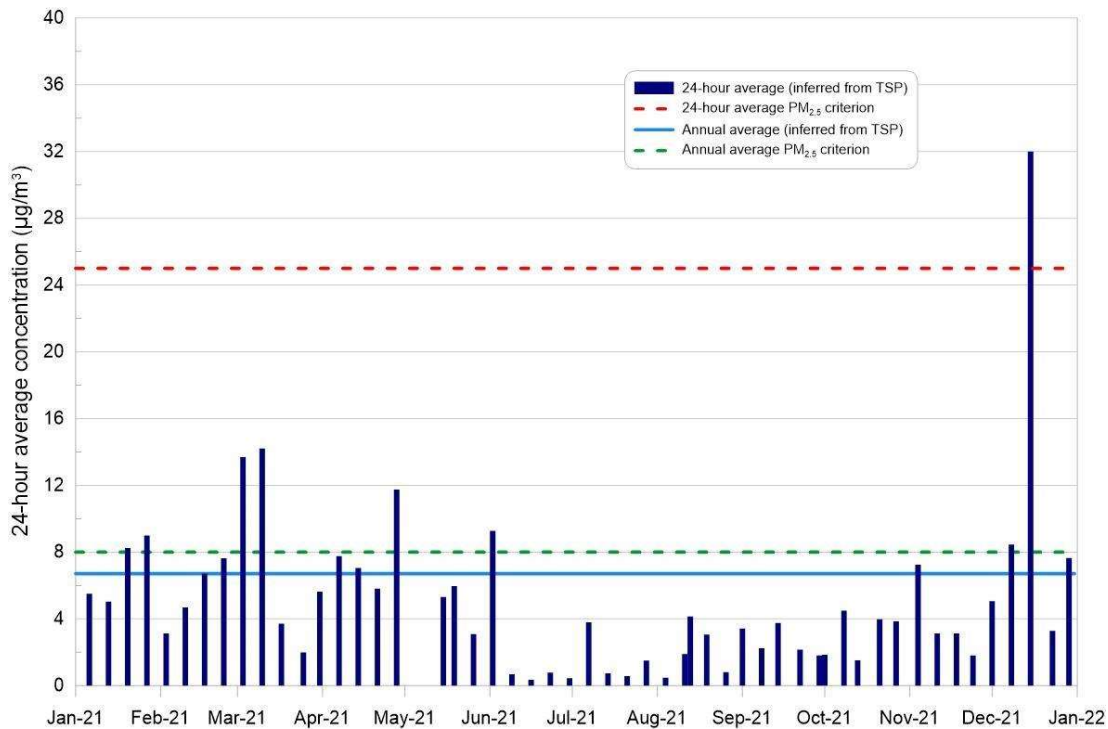
**Graph 6:**  $\text{PM}_{2.5}$  data inferred from TSP measurements – 2021

Like  $\text{PM}_{10}$ ,  $\text{PM}_{2.5}$  is not measured directly but again is inferred from TSP. An HVAS with a  $\text{PM}_{2.5}$  head will be co-located with the TSP HVAS to carry out direct measurements of  $\text{PM}_{2.5}$  prior to the commencement of underground production. In the meantime, the following methodology has been used to estimate  $\text{PM}_{2.5}$  concentrations. Historical data from co-located  $\text{PM}_{10}$  and  $\text{PM}_{2.5}$  monitors in the Hunter Valley have determined that the ratio between the two, for a non-urban environment, is approximately 40%. That is, typically 40% of  $\text{PM}_{10}$  (or approximately 16% of TSP) falls within the  $\text{PM}_{2.5}$  size fraction (Zephyr Environmental, 2022). Graph 6 shows the  $\text{PM}_{2.5}$  data based on these TSP measurements. All inferred  $\text{PM}_{2.5}$  concentrations except one remain below the 24-hour average criterion. As described above for TSP, there was a dust storm on 15 December resulted in one highly elevated concentration on this day of  $32 \mu\text{g}/\text{m}^3$  (inferred from TSP). Despite this isolated high concentration, the annual average of  $4.9 \mu\text{g}/\text{m}^3$  remained well below the annual criterion of  $8 \mu\text{g}/\text{m}^3$ . The inferred annual average  $\text{PM}_{2.5}$  concentration is also well below the long-term average of  $8 \mu\text{g}/\text{m}^3$ , as shown in Graph 7.

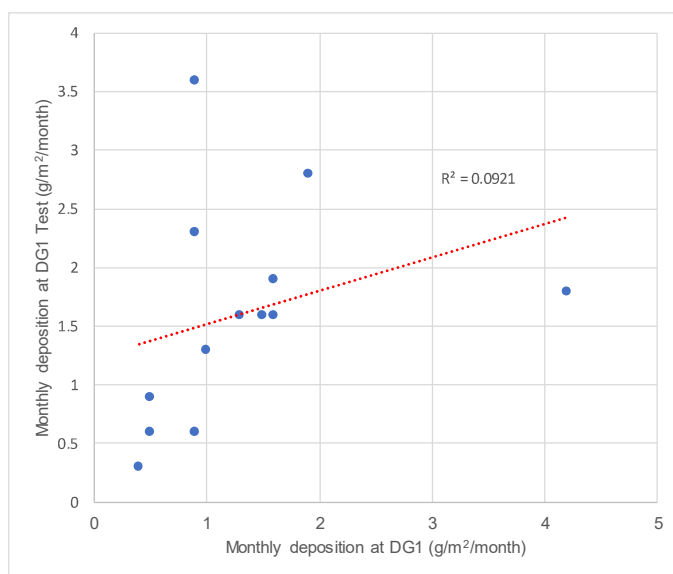
**Graph 8:** Correlation between monthly deposition levels at DG1 and DG1 Test

It is suggested that depositional dust network be downsized to reflect this, with preference given to the HVAS and continuous measurements of airborne particulates. Reasonable coverage and representation could be achieved by retaining DG01, DG09, DG14 and McLintocks Shed. This would cover the areas to the north, south, east and west, as well as retaining a co-located gauges with the HVAS (DG01) and a site representative of the lake (DG14) (Zephyr Environmental, 2022).

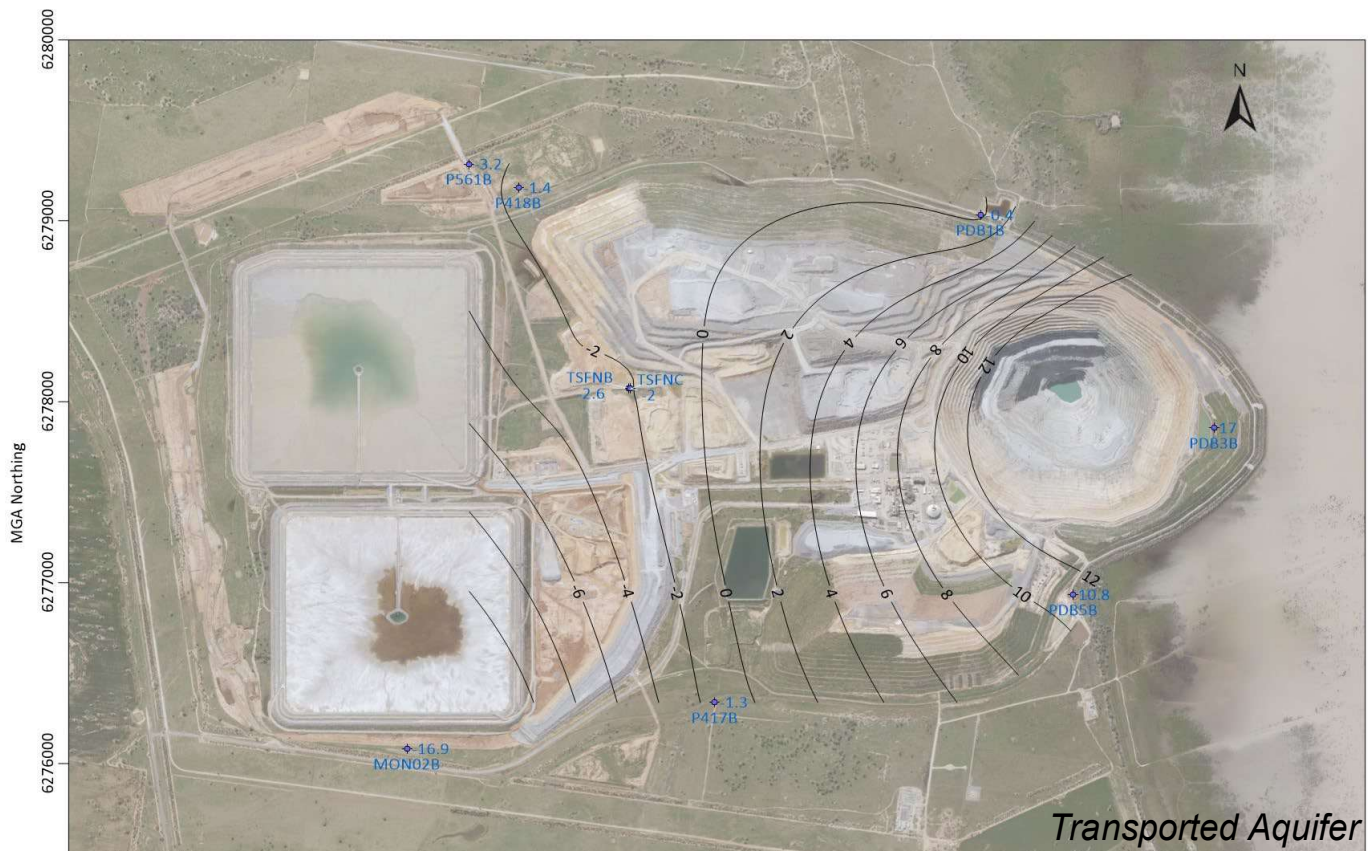
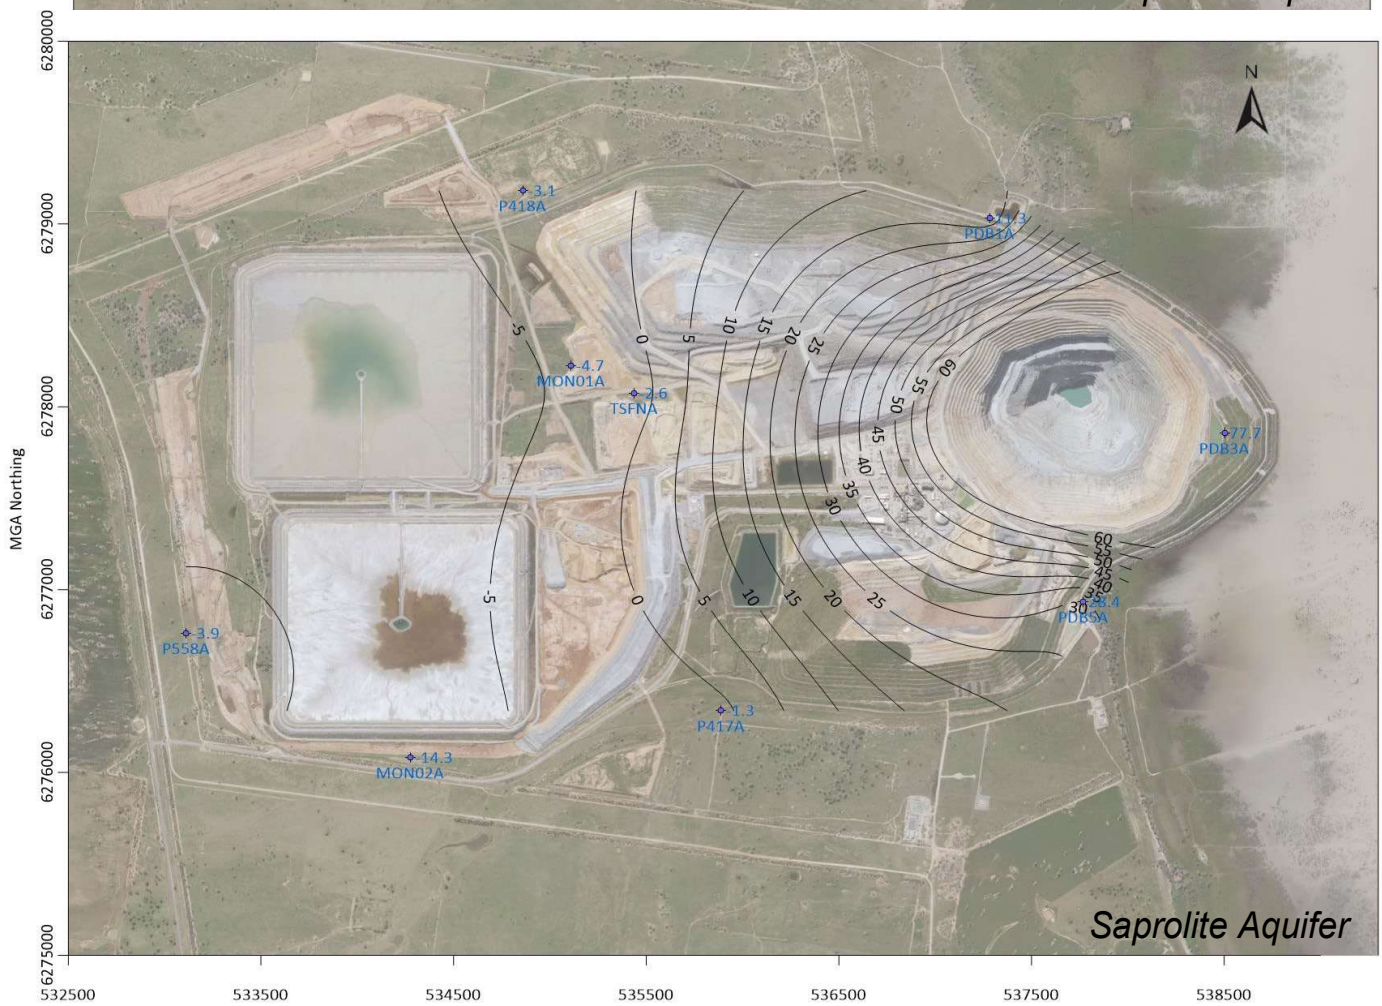
**FIGURE 11**  
Piper Plot of Groundwater  
Chemistry

*Transported Aquifer*

*Saprolite Aquifer*

Source: EGI (2022)

A Groundwater Monitoring Review 2021 report has been prepared by Environmental Geochemistry International (2022), which provides a detailed description and interpretation of the groundwater monitoring results during the reporting period. Piper Plots of groundwater chemistry of the BCPC Bore field, processing plant area bores, pit area bores and TSF bores are provided on Figure 11. Contour maps of the hydraulic head and groundwater drawdown are presented in Figures 12 and 13, respectively. Key summaries of the groundwater monitoring results presented in EGI (2022) are provided in the subsections below.

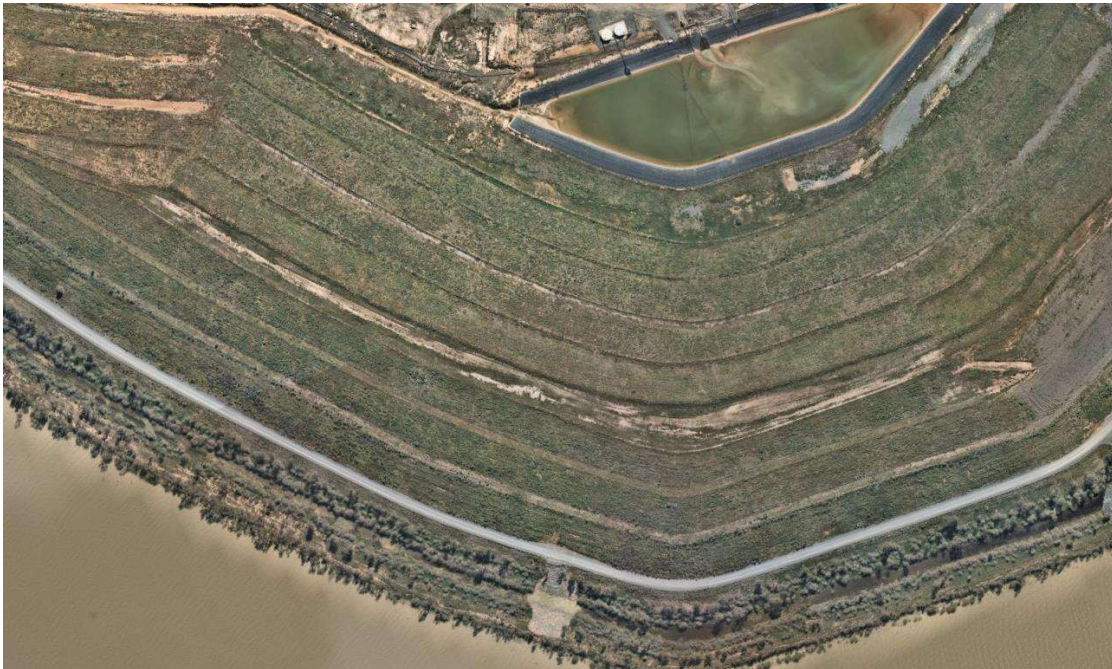
**Plate 2: Aerial View Perimeter Waste Rock Emplacement (October 2021)**

Approximately 21ha of the inner and outer perimeter wall was previously seeded and 6ha were reshaped and rock armoured. Both areas were monitored for stabilisation and effectiveness of seeding during the 2021 reporting period.

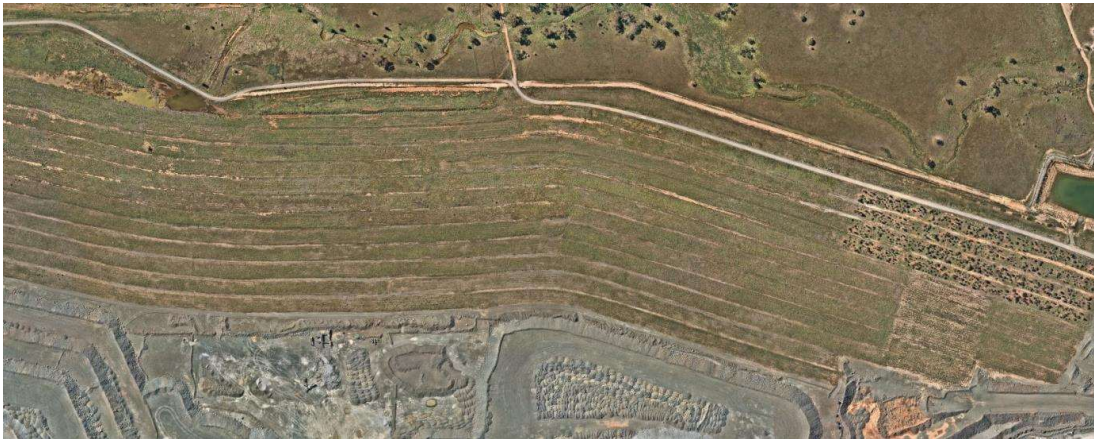
### **Plate 3: Aerial View Northern Waste Rock Emplacement (October 2021)**

The NWRE is approved to be constructed to approximately 308 m AHD and will occupy an area of approximately 269 ha northwest of the pit (Plate 2).

Tube stock planted in previous years on the NWRE was monitored during the reporting period.

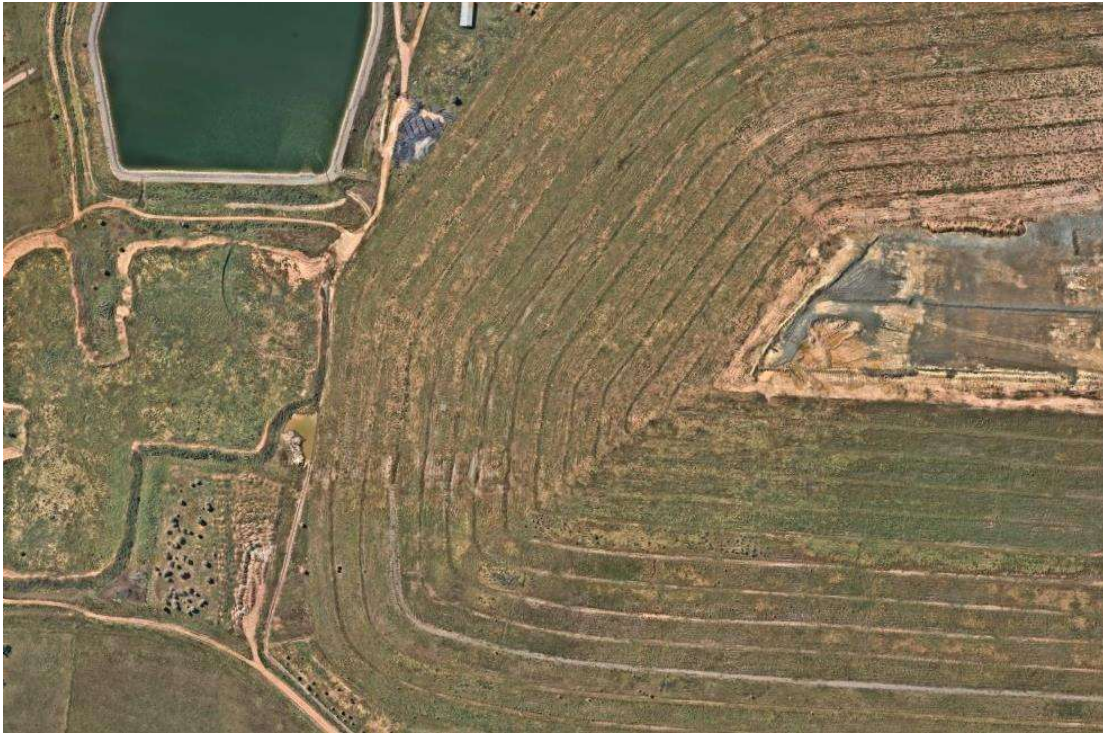
**Plate 4: Aerial View - Southern Waste Rock Emplacement (October 2021)**

Area of approximately 18ha on the SWRE batters were rock armoured, topsoiled, gypsum spread and were direct seeded via aerial application during previous reporting periods and was monitored during the 2021 reporting period.

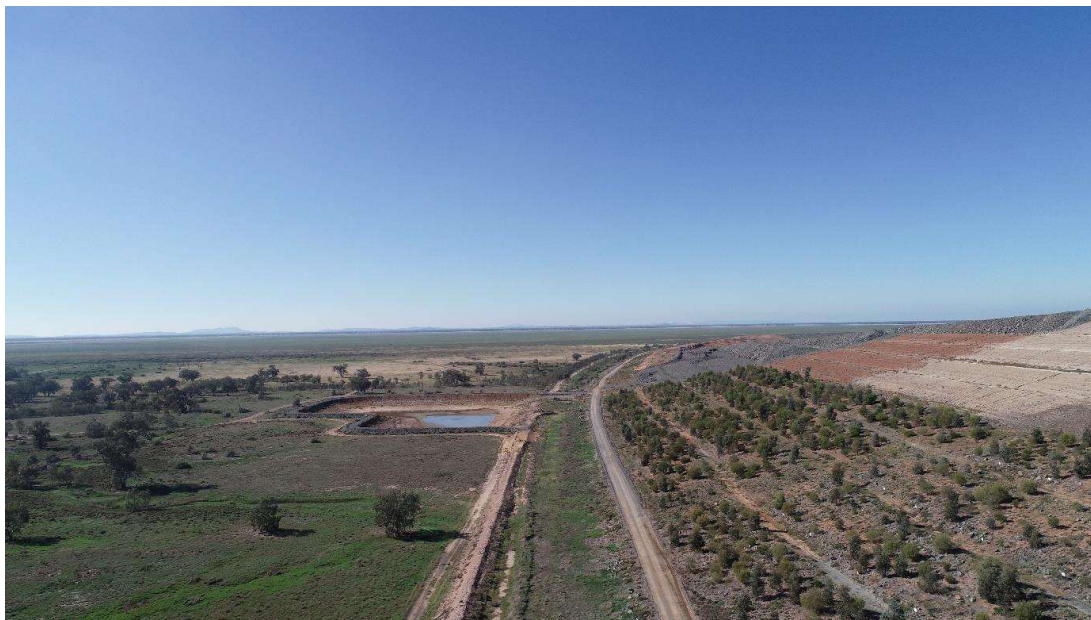
**Plate 5: NWRE – Pond D1 North Trial Tube stock**

These trials will continue during the next reporting period.
