COWAL GOLD OPERATIONS

2022 ANNUAL REVIEW

Name of Operation	<i>Cowal Gold Operations</i>
Name of Operator	<i>Evolution Mining (Cowal) Pty Limited</i>
Development Consent	<i>DA 14/98 and SSD 10367</i>
Name of Holder of Development Consent	<i>Evolution Mining (Cowal) Pty Limited</i>
Mining Lease #	<i>ML 1535</i>
Name of Holder of Mining Lease	<i>Evolution Mining (Cowal) Pty Limited</i>
Mining Lease #	<i>ML 1791</i>
Name of Holder of Mining Lease	<i>Evolution Mining (Cowal) Pty Limited</i>
Environmental Protection Licence #	<i>EPL11912</i>
Name of Holder of EPL	<i>Evolution Mining (Cowal) Pty Limited</i>
Water Licence #	<i>WAL 36569, WAL 31864, WAL 36615, WAL 36617, WAL 13749, WAL 14981, WAL 13748, WAL 13748, WAL 31568, WAL 31563, WAL 42993</i>
Name of Holder of Water Licences	<i>Evolution Mining (Cowal) Pty Limited</i>
Annual Review Start Date	<i>1 January 2022</i>
Annual Review End Date	<i>31 December 2022</i>

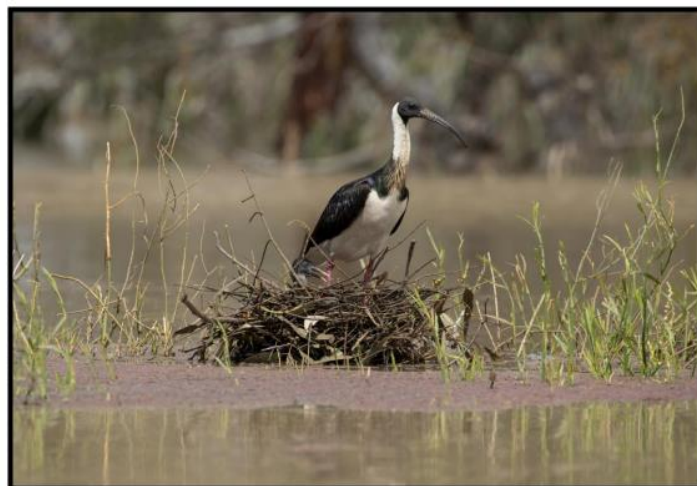
Colonial breeding had recommenced with almost 1200 nests observed. Ongoing rise in water levels inundated most nests (Plate 2) and substantial losses were observed.

Plate 2. Straw-necked Ibis nest with adult and young at water level

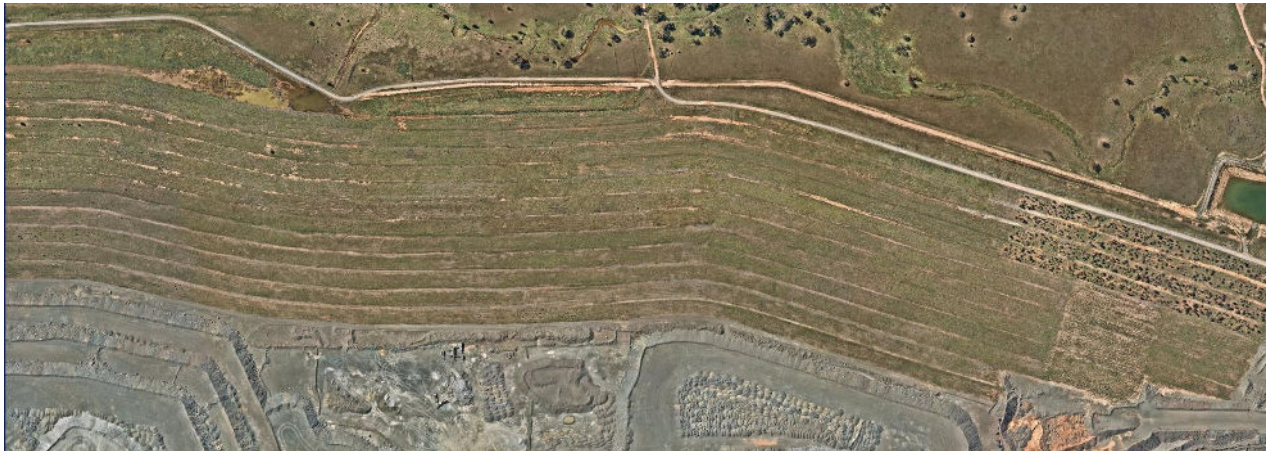
Plate 5: Aerial View Northern Waste Rock Emplacement (February 2023)

The NWRE is approved to be constructed to approximately 308 mAHD and will occupy an area of approximately 313 ha northwest of the pit (Plate 5).

Tube stock planted in previous years on the NWRE was monitored during this reporting period.

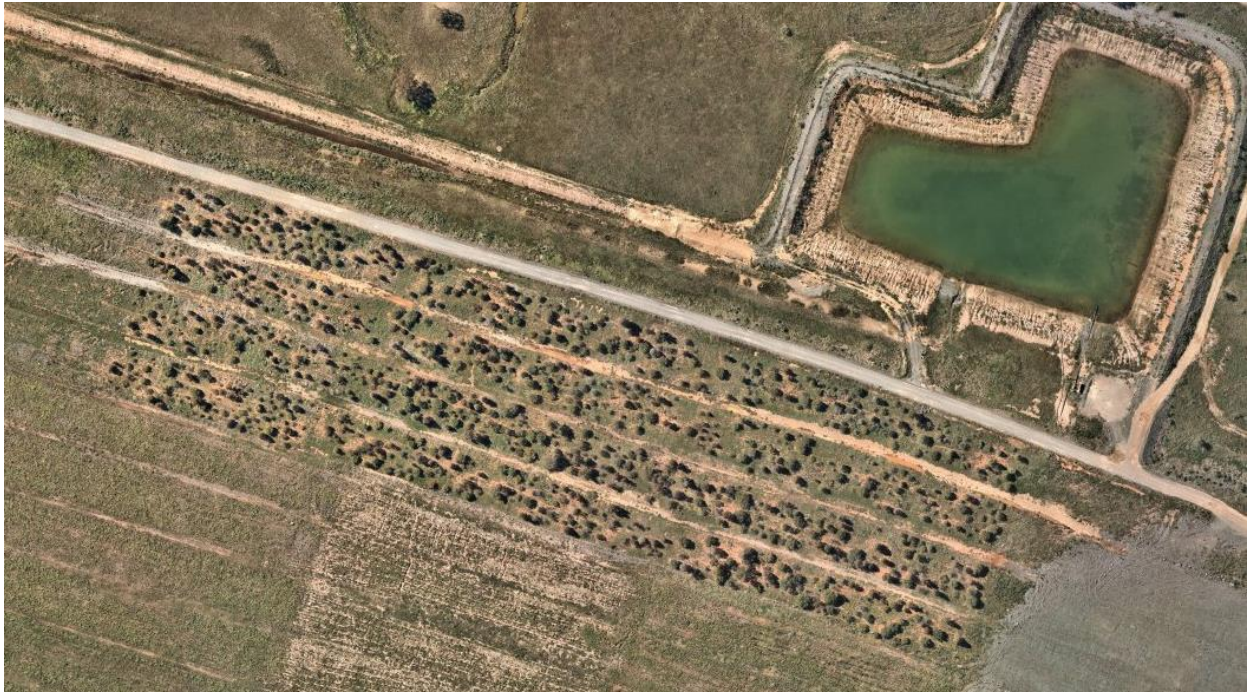
Plate 7: NWRE – Pond D1 North Trial Tube stock (February 2023)

Plate 7 shows the NWRE trial site, and monitoring will continue during future reporting periods.
