# Cowal Gold Operations

Monitoring Programme for Detection of any Movement of  
Lake Protection Bund, Water Storage and Tailings Structures  
and Pit Void Walls

JULY 2018  
Project No. HAL-02-07  
Document No. LPBMP01-N  
ID: 00856291

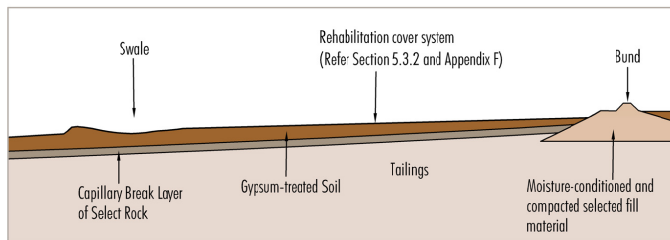
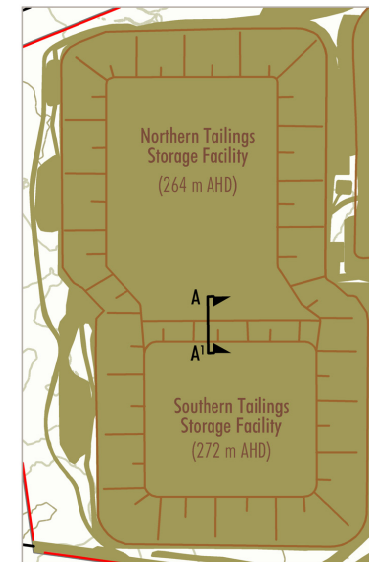
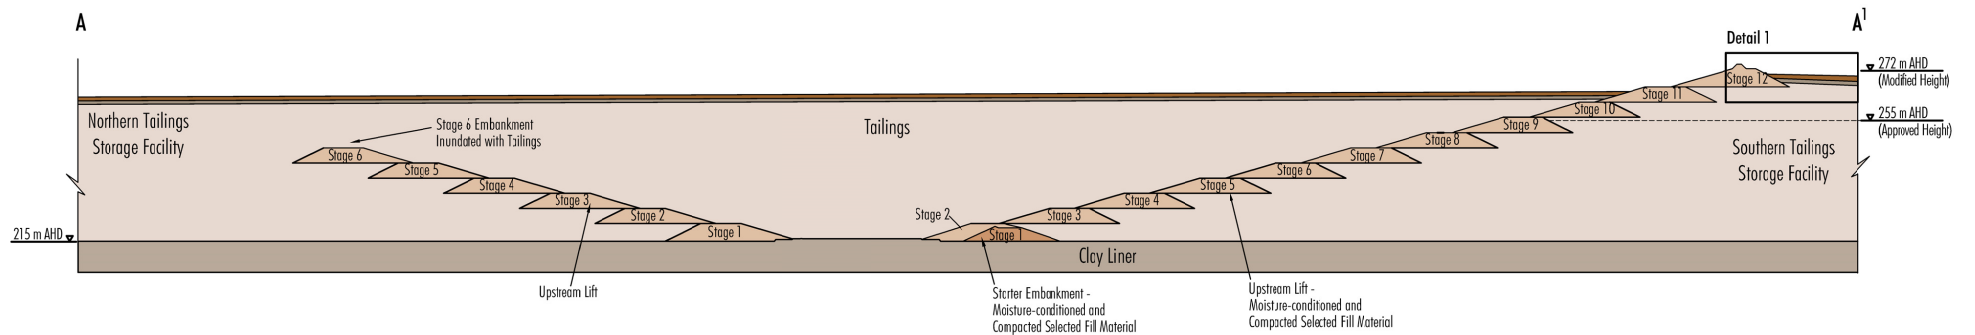
FIGURE 3

DETAIL 1

Conceptual Cross-section of  
Central Tailings Storage Facility Area

The northern tailings storage facility and central section will then act as one continuous area for tailings deposition (Figure 3), with the existing decant causeway for the northern tailings storage facility extended to the northern face of the southern tailings storage facility embankment (Figure 4). The approximate final heights of the northern and southern tailings storage facilities will increase to approximately 264 m AHD and 272 m AHD, respectively.

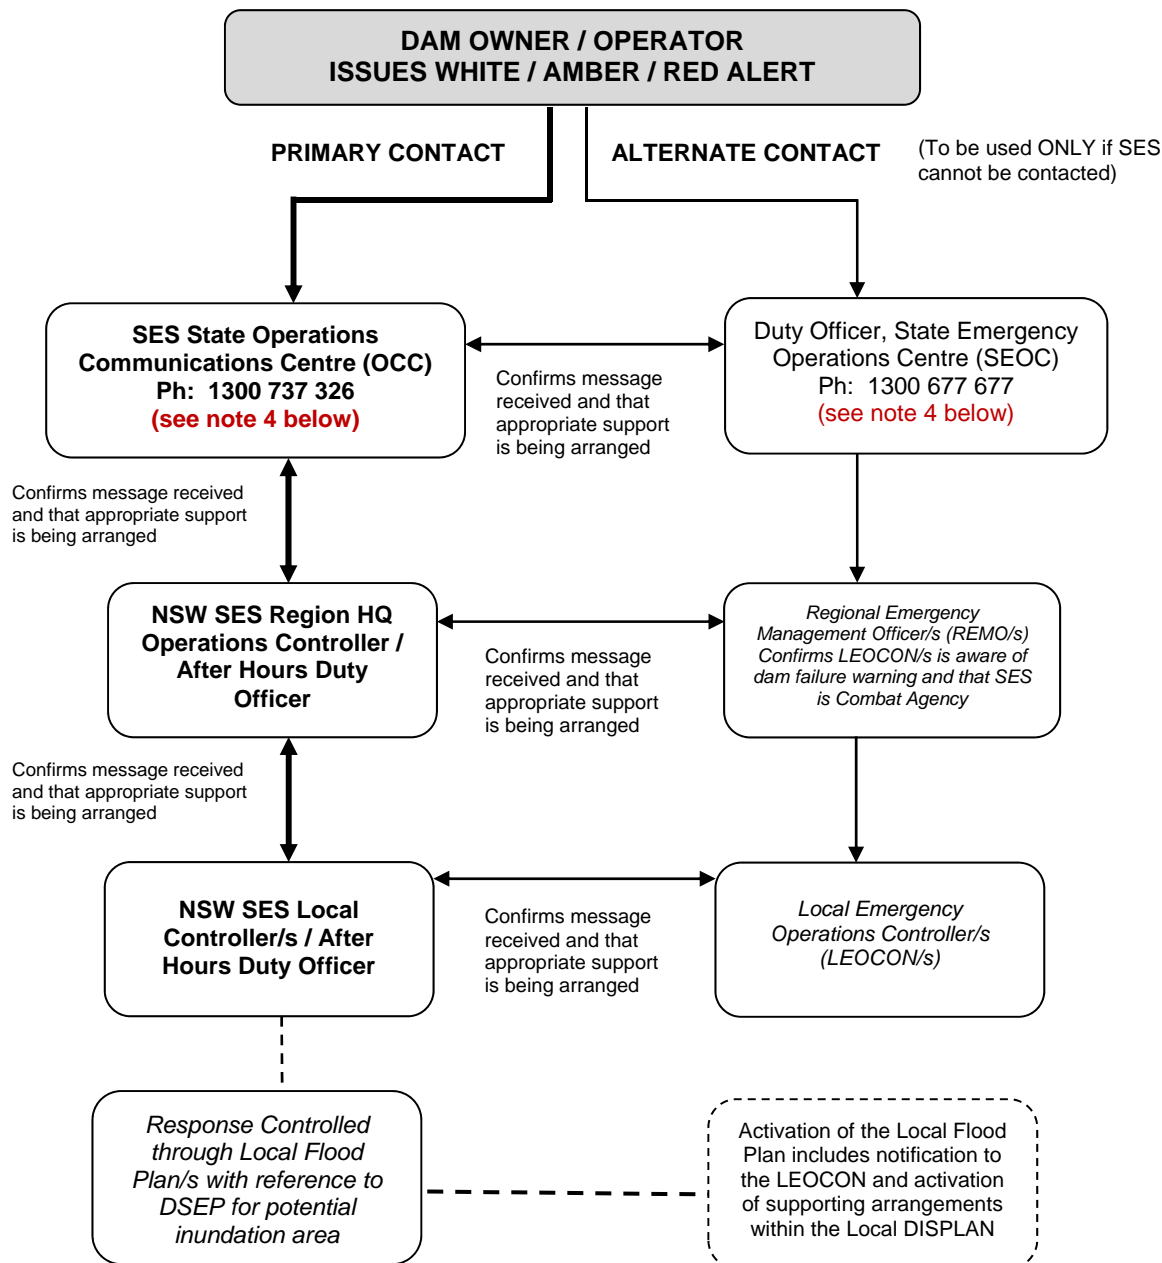
## Notification Arrangements for Potential Dam Failure

1. Dam owners should only contact the SEOC if the SES State Operations Communications Centre (OCC) cannot be contacted.
2. The first priority for notification is to contact the next SES HQ or the next level of EOC down the flowchart. The second notification should always be across the flow chart to confirm the message is received. If the first priority notification fails or is not picked up for any reason, the second priority notification should be made before any further attempts to contact the first priority (this is why an alternate or backup system of contracts is in place).
